# Intelligent Compaction and Infrared Scanning Field Projects with Consulting Support

Final Report Prepared for Missouri Department of Transportation  
February 2018 Project TR201716 Report cmr18-003

# **Intelligent Compaction and Infrared Scanning Field Projects with Consulting Support Final Report**

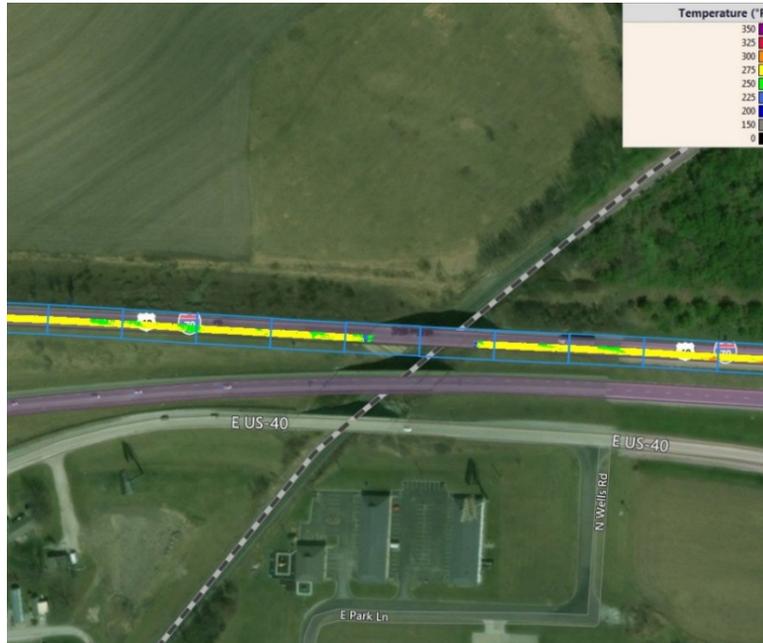
**Figure 28: Example of a Veta Sublot screen for IR data analysis (J3I3042, RT70).**

Note the data gap at a bridge in the screenshot in Figure 28. The data gap is due to the fact that there was no HMA placed on the bridge, and since the temperature of the surface was below the threshold of 80oC, the data was filtered out by the MOBA. However, it is recommended that the MOBA system be left “ON” while the paver mobilizes across a bridge (or similar situation) as the distance data is continued to be collected and is used in data analysis.

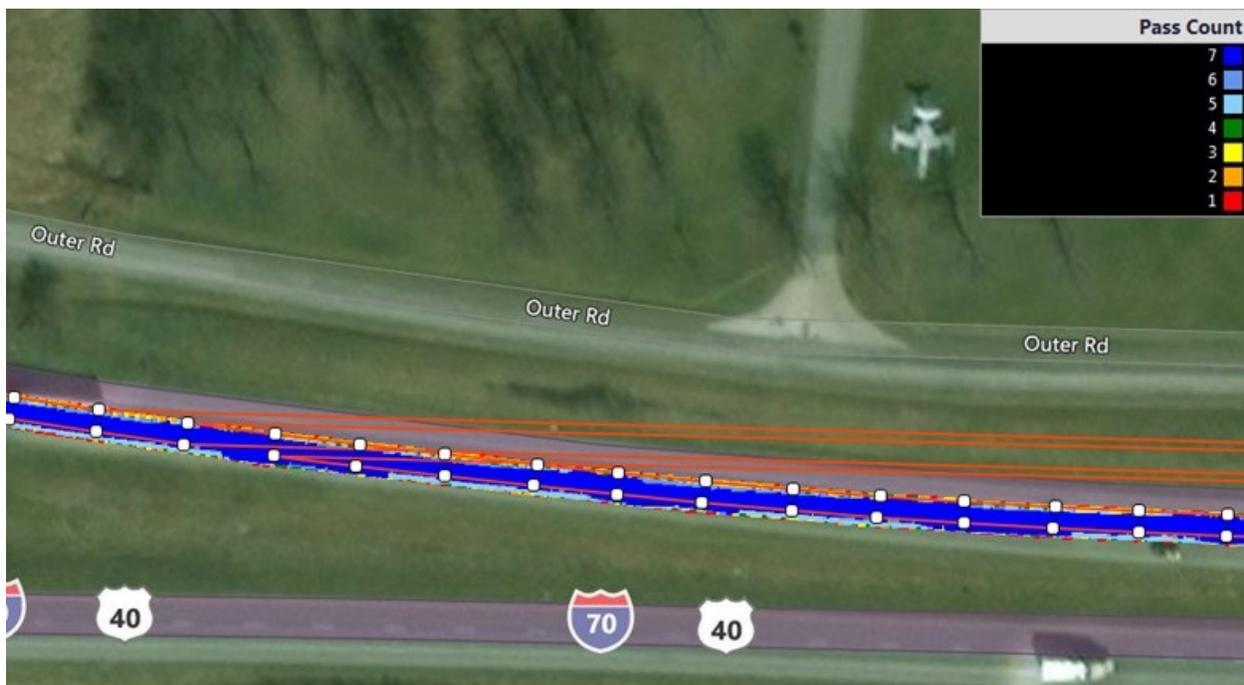
**Figure 65: Incorrect Boundary File for 8/23/2017 (Project No. 3 - J3I3042, I-70).**

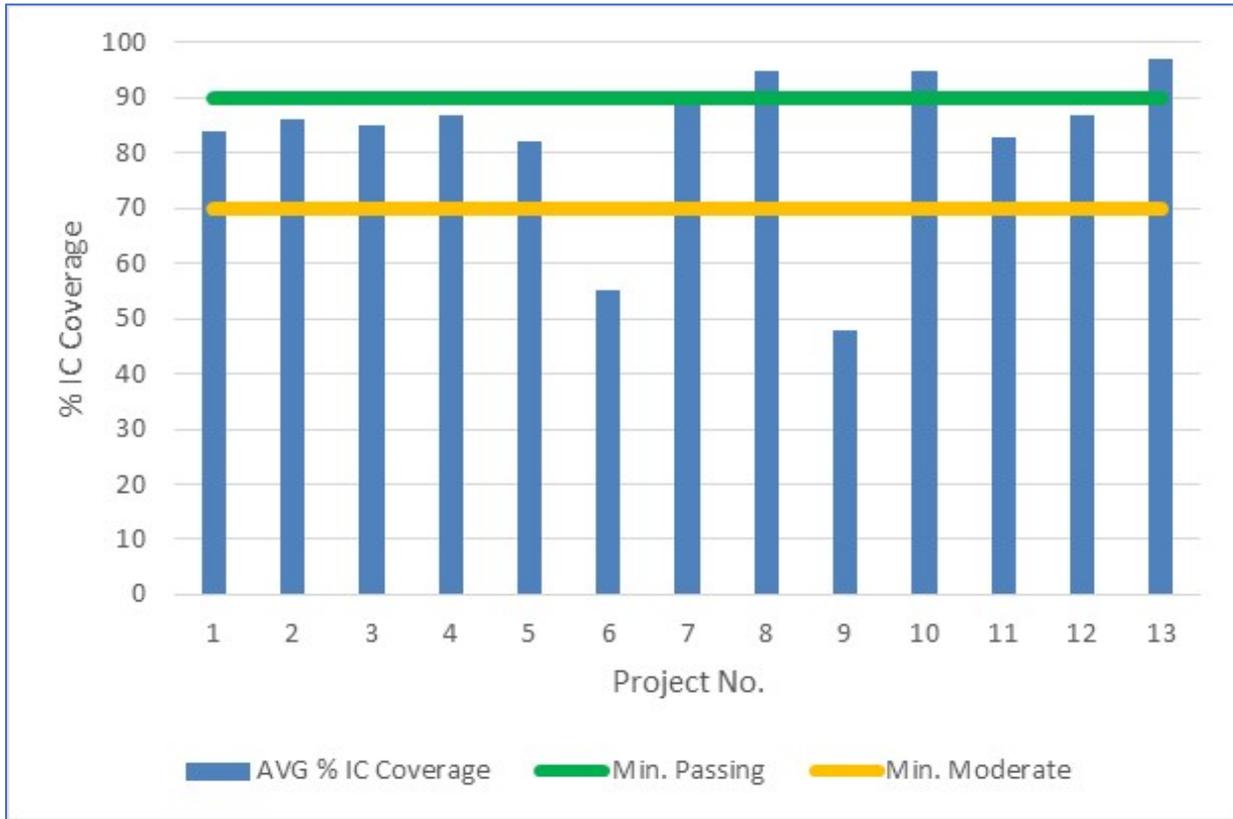
**Figure 111: Comparison of IC Coverage for all projects.**

In terms of mean values of target pass coverage for all projects, there were projects (No. 6 and 9) that did not meet the 70% minimum coverage requirements (i.e., deficient), there were projects (No. 7, 8, 10, and 13) that met the 90% excellent coverage (i.e., passed), and there were projects (No. 1, 2, 3, 4, 5, 11, and 12) which fell in between the above. Figure 111 provides an overall summary of IC coverage for all projects.
