MoDOT Publication No. cmr 18-003
MoDOT Projects No. TR201716/ TR201802

Intelligent Compaction and Infrared Scanning Field Projects with Consulting Support Final Report

January 2018

The Transtec Group, Inc.
6111 Balcones Drive
Austin, Texas 78731

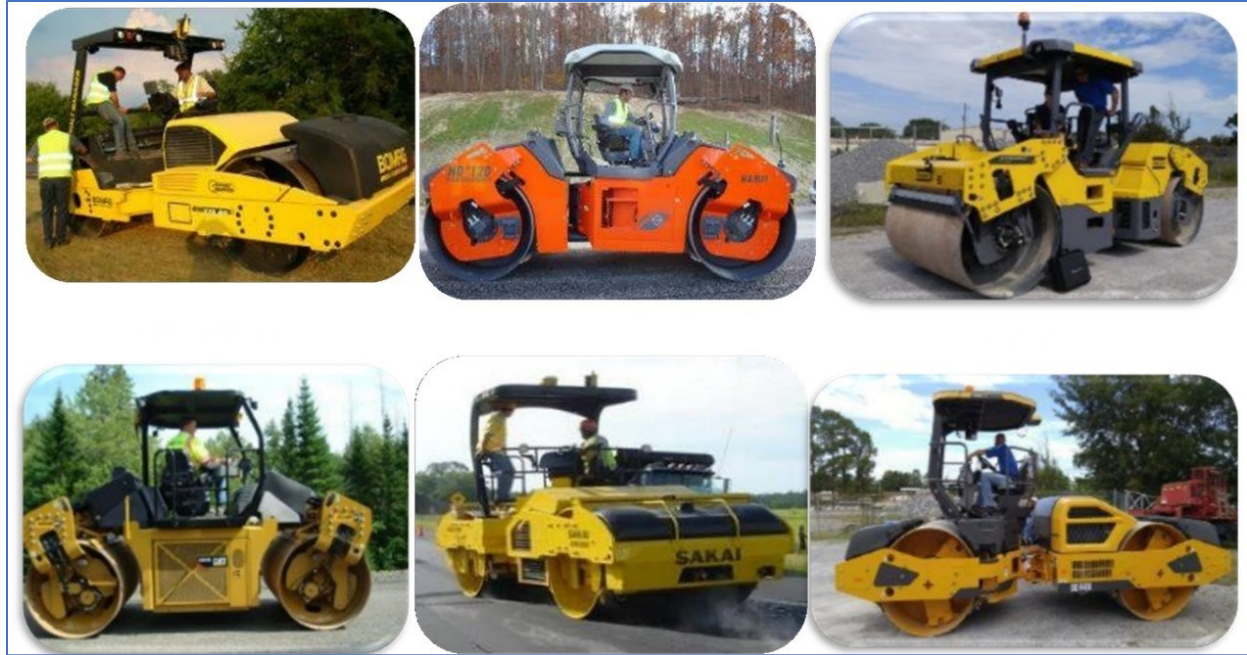
Figure 2. Examples of OEM Double-Drum IC Rollers.

IC systems are available in two forms: Original Engineering Manufacture (OEM, Figure 2) and after-market IC retrofit (Figure 3). The OEM is directly from roller vendor's factory. The IC retrofit can be mounted on selected models of rollers.

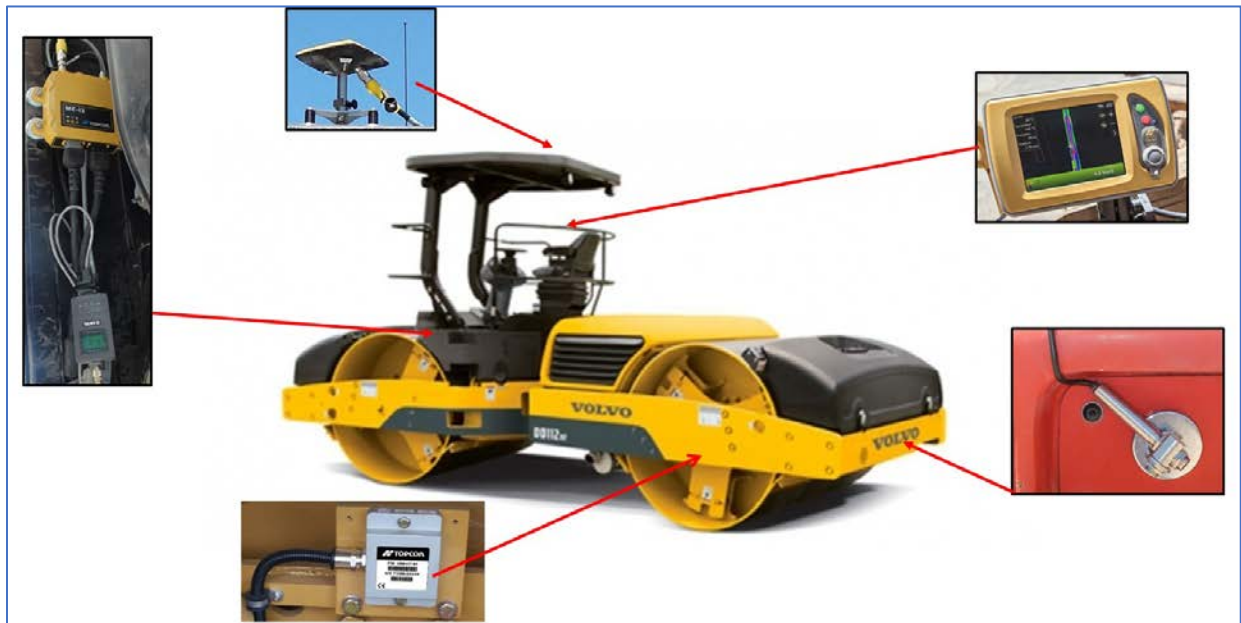
Figure 3. An Example of IC Retrofit Systems.

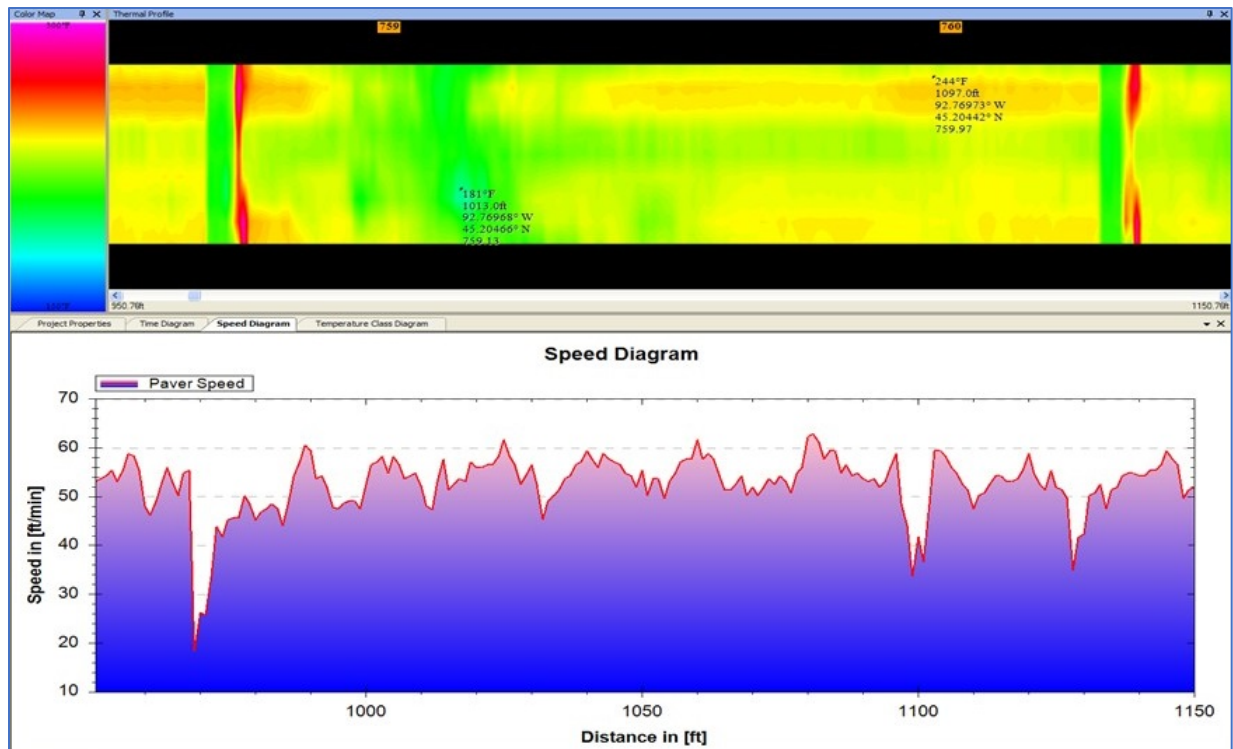
Figure 6. An Example of IR Display of Thermal Profiles and Paver-Speed.

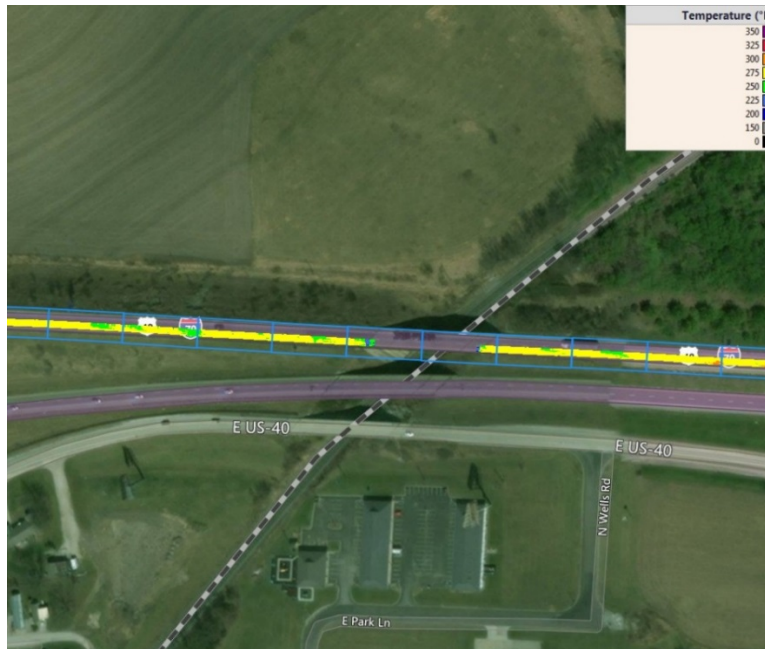
Figure 28: Example of a Veta Sublot screen for IR data analysis (J3I3042, RT70).

Note the data gap at a bridge in the screenshot in Figure 28. The data gap is due to the fact that there was no HMA placed on the bridge, and since the temperature of the surface was below the threshold of 80oC, the data was filtered out by the MOBA. However, it is recommended that the MOBA system be left “ON” while the paver mobilizes across a bridge (or similar situation) as the distance data is continued to be collected and is used in data analysis.

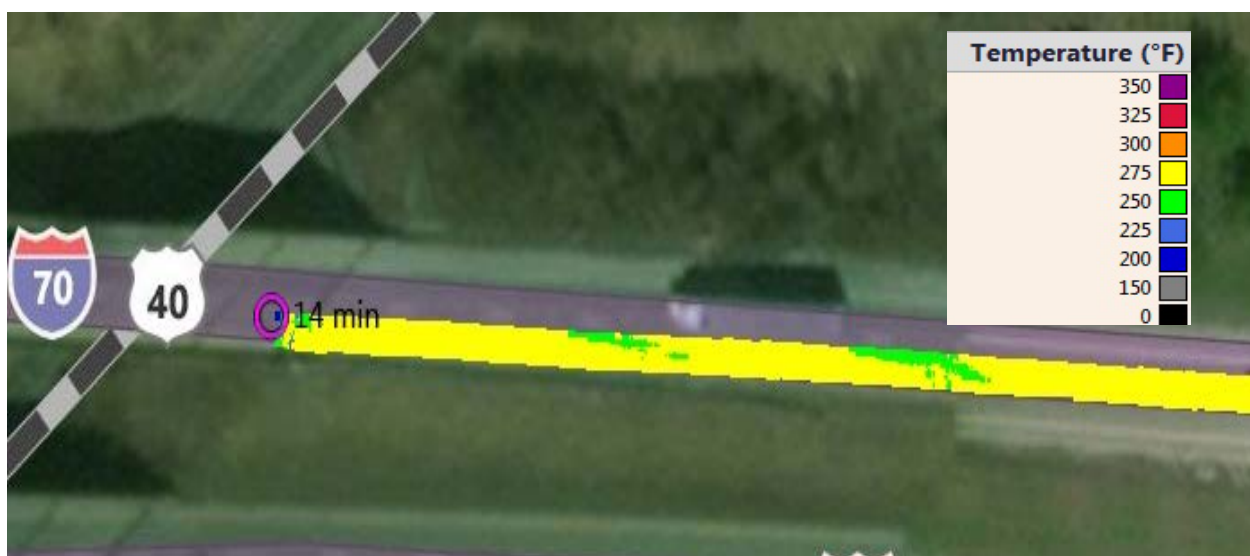
The Paver Stop map (Figure 31) plots a pink circle indicating paver stop locations, and text indicating stop duration in minutes.

Figure 31: Example of a Veta Paver Stop plot (J3I3042, RT70).

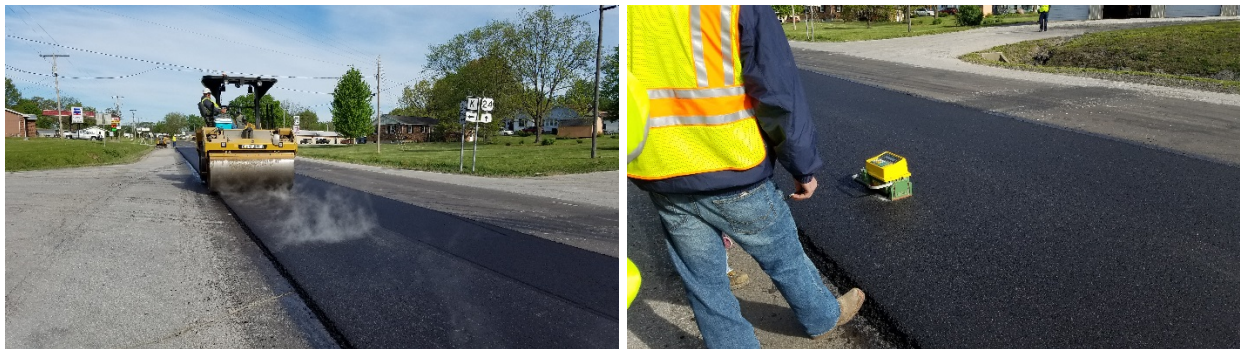
- Section: The initial 1,500 ft. of the paved area (Figure 38).
- A nuclear density gauge was used to perform spot tests of density. Readings were taken at exactly the same spots after each pass.
- Optimum Rolling Pattern

Figure 38: Trial Section Tests on 4/24/2017 (J1P3005 RT 24).

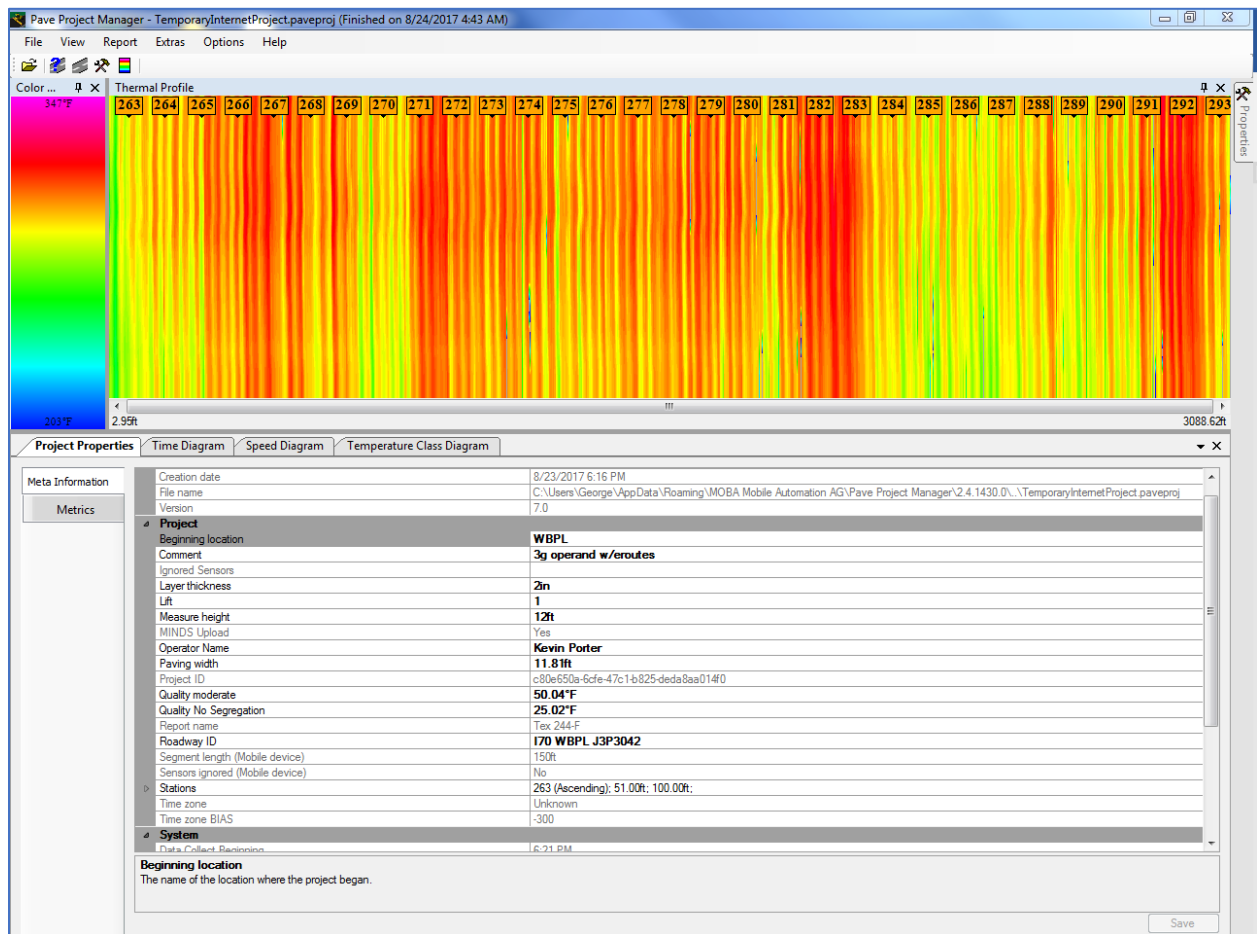
Figure 60: Incorrect distance reported by MOBA PPM for the data on 8/23/2017 (J3I3042, I-70).

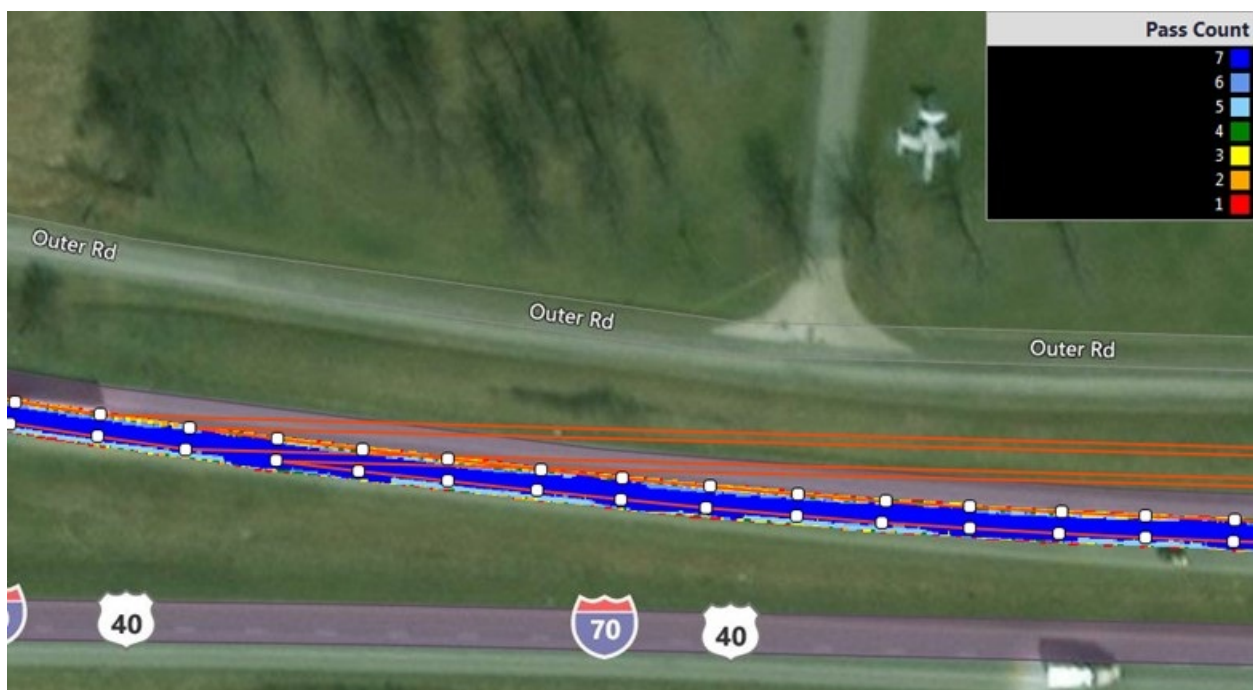
Figure 65: Incorrect Boundary File for 8/23/2017 (Project No. 3 - J3I3042, I-70).
