Consultant Support for IC-PMTPS Projects

2018 Final Report

Missouri Department of Transportation
1617 Missouri Blvd.
Jefferson City MO 65102

The Transtec Group, Inc.
6111 Balcones Drive
Austin, Texas 78731

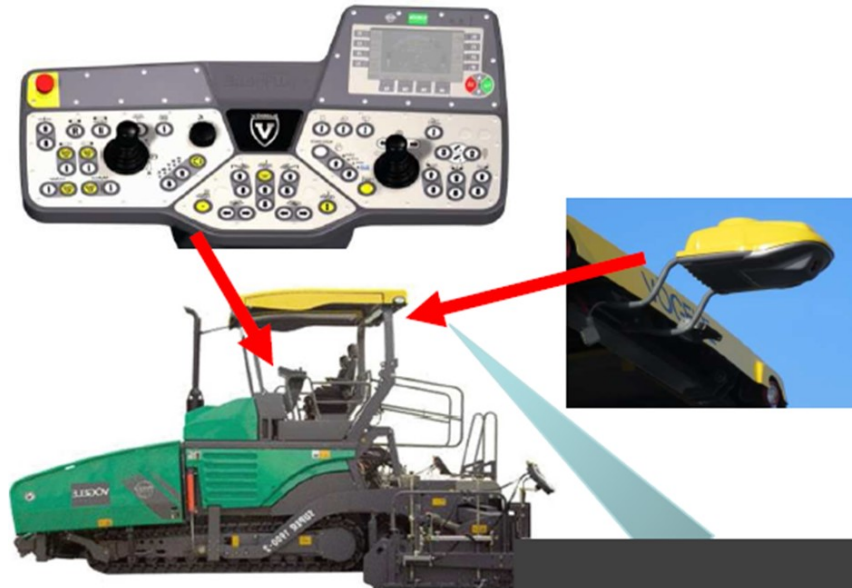
Figure 1. Vogele RoadScan thermal imaging system

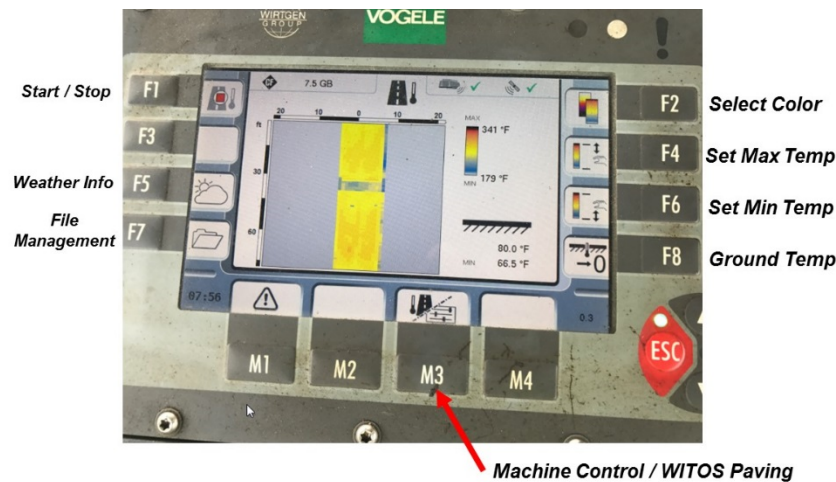
Figure 2. Vogele RoadScan thermal imaging system: Control Panel

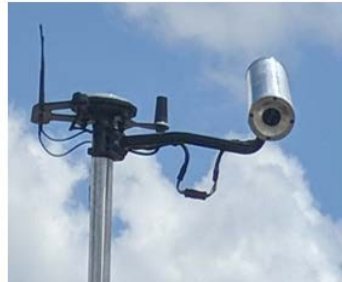
Figure 4. Trimble/Caterpillar thermal imaging system

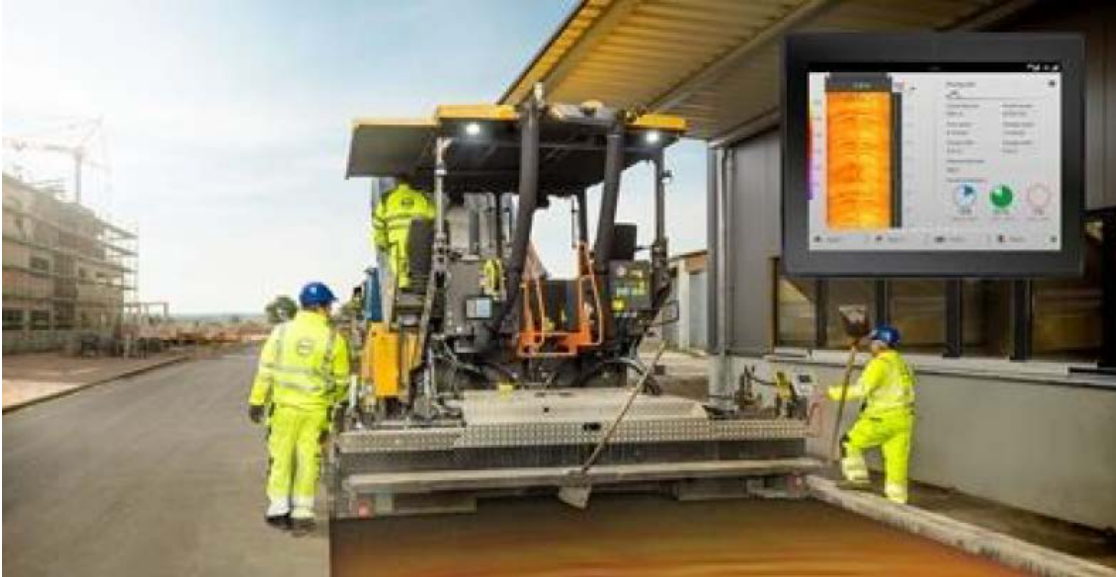
Figure 5. Volvo PaveAssist thermal imaging system

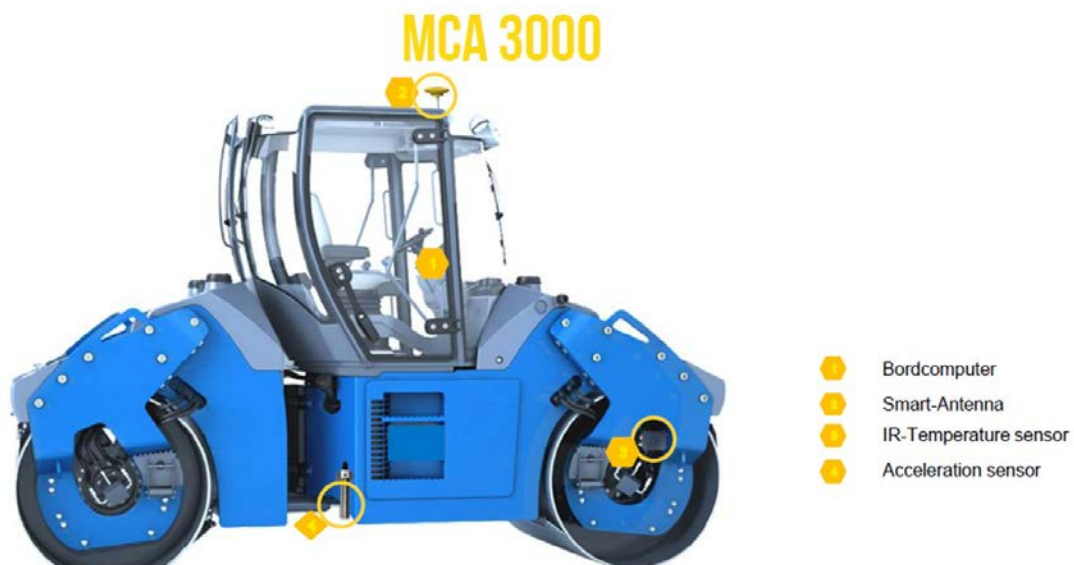
Figure 6. MOBA MCA (MOBA Compaction Assist)

MOBA MCA (MOBA Compaction Assist) with Level 3-4 ICMV (as advance IC system for improved ICMV measurements) The prototype may be available in 2019. A brief description of this innovative technology is as follows.

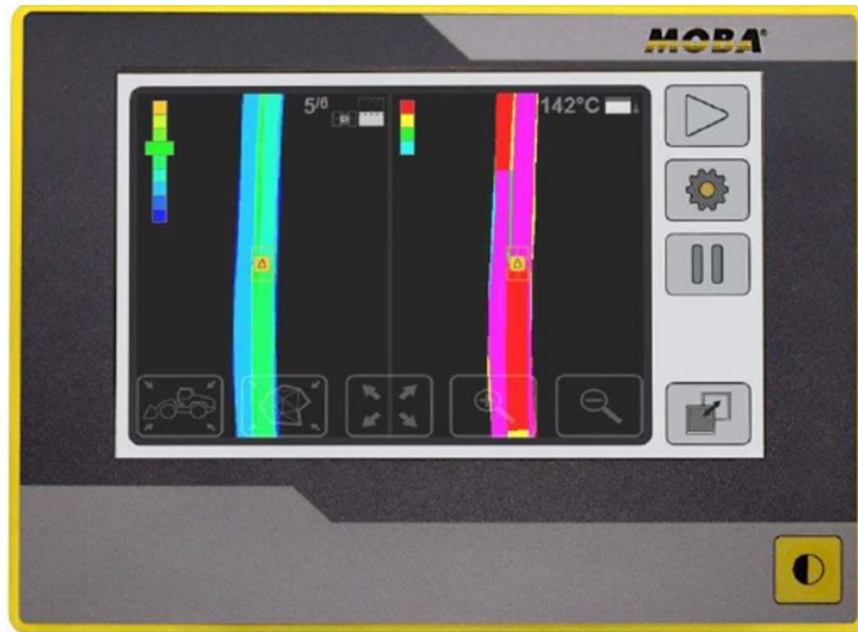
Figure 7. MOBA MCA (MOBA Compaction Assist): Onboard Display

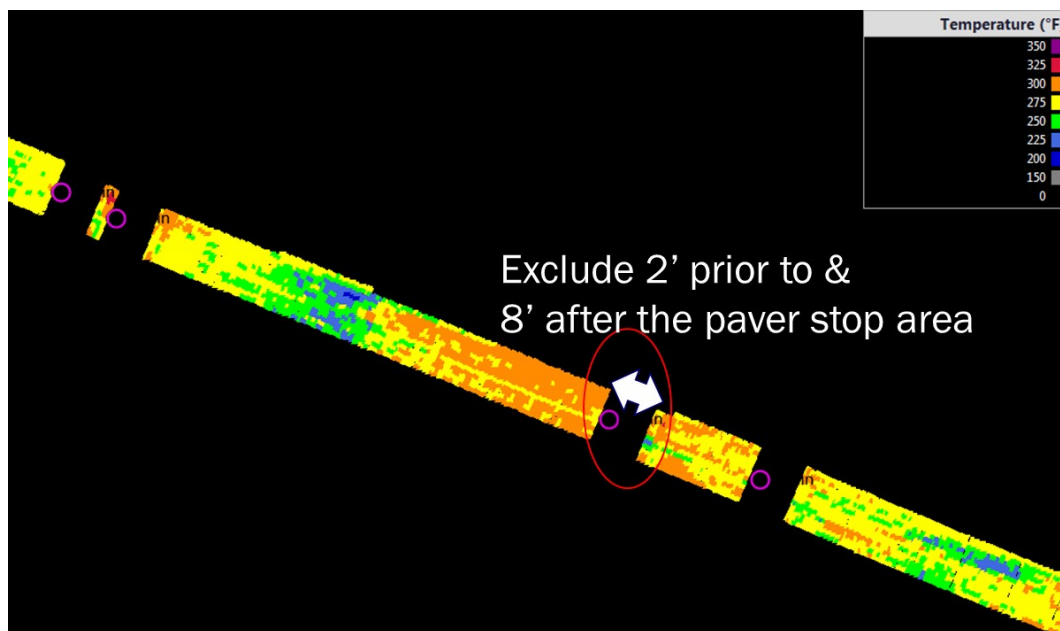
Figure 9: AASHTO PP80 IR Analysis Method: 10' exclusion around a paver stop location

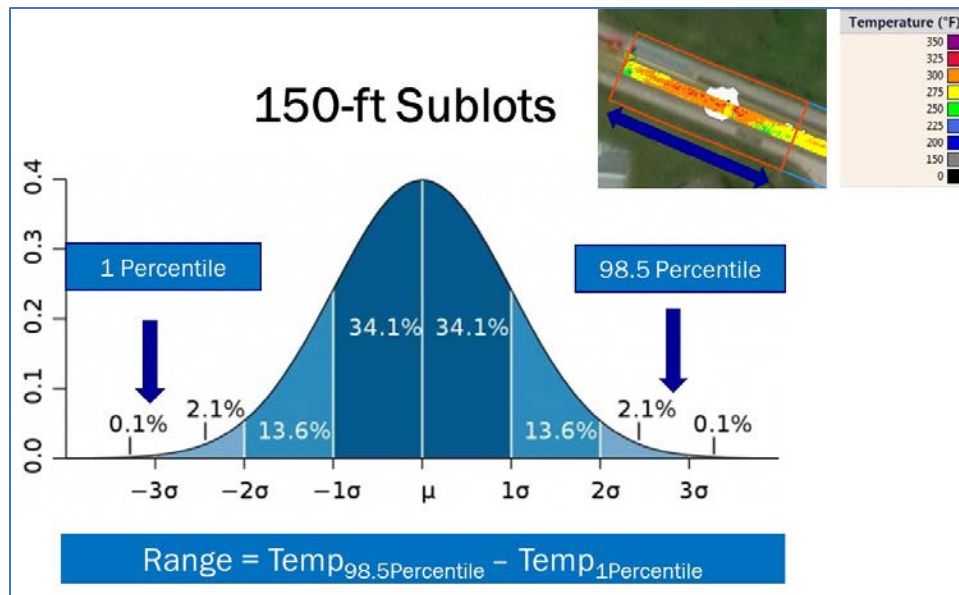
Figure 10: AASHTO PP80 IR Analysis Method: Computation of “Range” value

The remaining data are used to calculate the Range value, 98.5th percentile – 1th percentile (Figure 10). The classification of temperature segregation is based on the Range value as follows: Low (Range ≤ 25.0 °F); Moderate (25.0 °F < Range ≤ 50.0 °F); and Severe (Range > 50.0 °F), as shown in Figure 11. The temperature segregation based on the above analysis method does not consider the effects of paver stops.

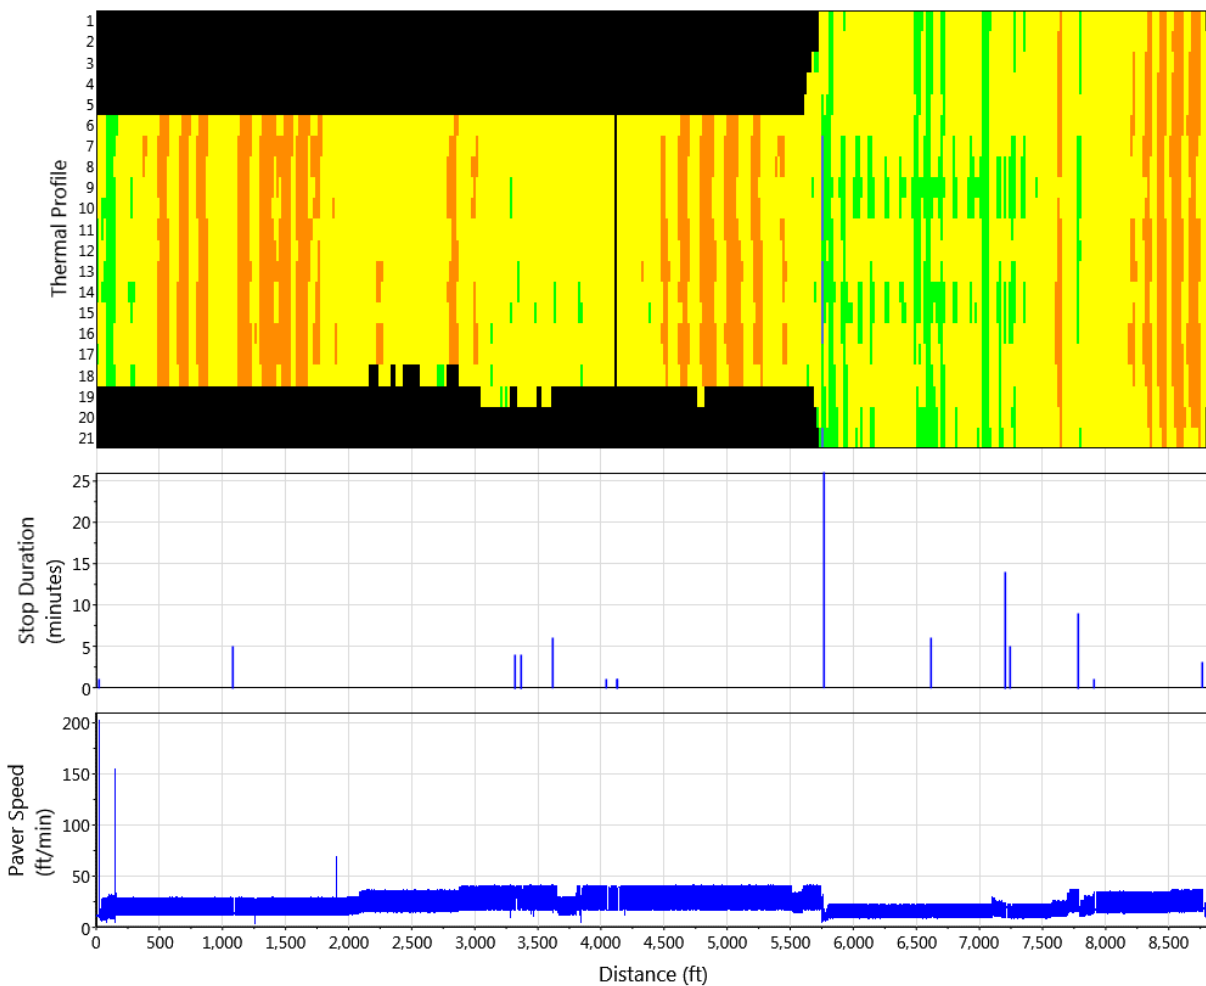
The thermal profile, paver stops, and speed plots are as follows. Note that the thermal profile width changes at 5,550ft. It is recommended to verify with the contractor.

Figure 20: Veta Thermal Profile/Paver Stops/Paver Speed Screen of PMTP Data Analysis.

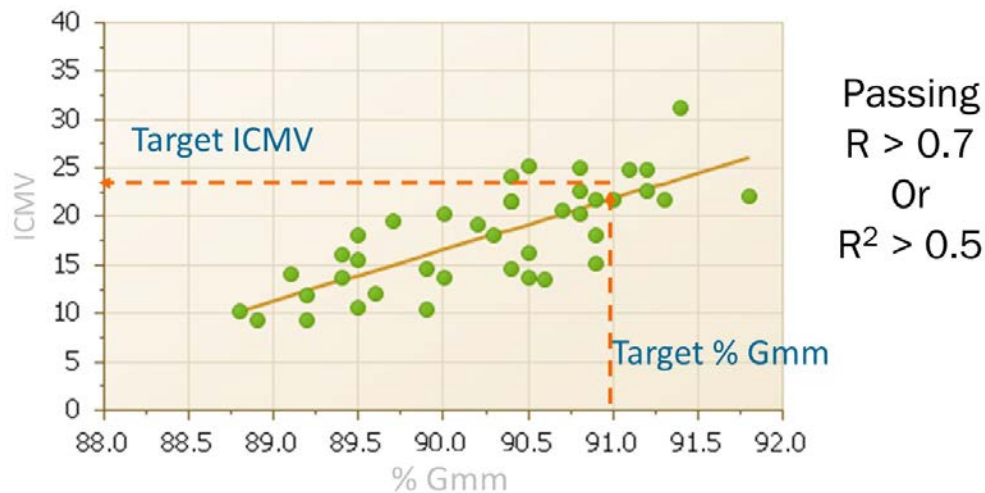
Figure 24: Target ICMV determined by Correlation between ICMV and Acceptance Spot Tests from Trial Section Data.

The target ICMV can be determined based on the correlation between the ICMV data and acceptance spot tests from the trial section (Figure 24). The requirements for the acceptable correlation between ICMV and acceptance spot tests is $R > 0.7$ or $R^2 > 0.5$, based on most of the international IC specifications.

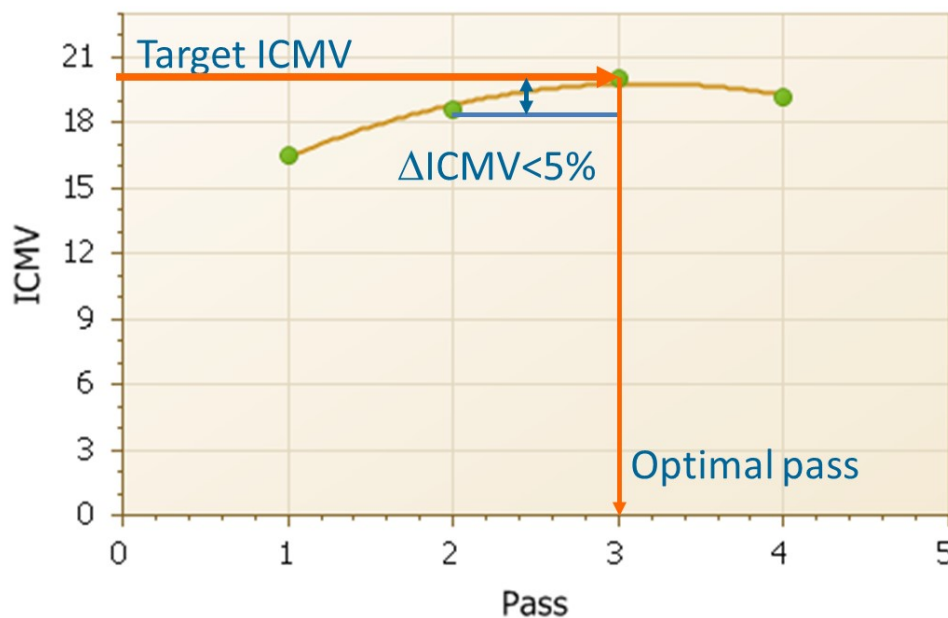
Figure 25: Target ICMV determined by an ICMV Compaction Curve when Acceptance Spot Tests from Trial Section Data are Not Available.

Since ICMV is measured only with vibratory passes, the projects that use only static passes or mix of vibratory/static passes did not have sufficient ICMV data for further analysis. When vibratory passes are used but without companion acceptance spot tests, the target ICMV and optimal passes can be determined based on the ICMV compaction curve where the increment of ICMV with each subsequent pass is less than 5% (Figure 25).

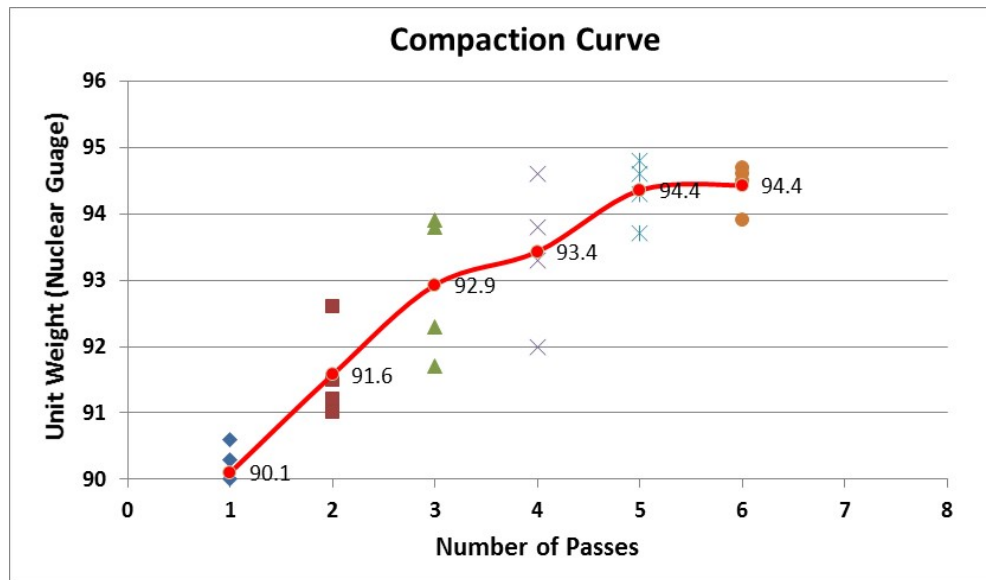
Import the TOPCON all-passes data (PLN) files from the two IC rollers to Veta 5.2 and save as J5S3207-20181022-IC.vetaproj. Based on the Trial Section NDG compaction curve and information provided by the contractor, the target is 5 vibratory passes.

Figure 28: Density Compaction Curve based on the Trial Section Data (J5S3207 RT 54).

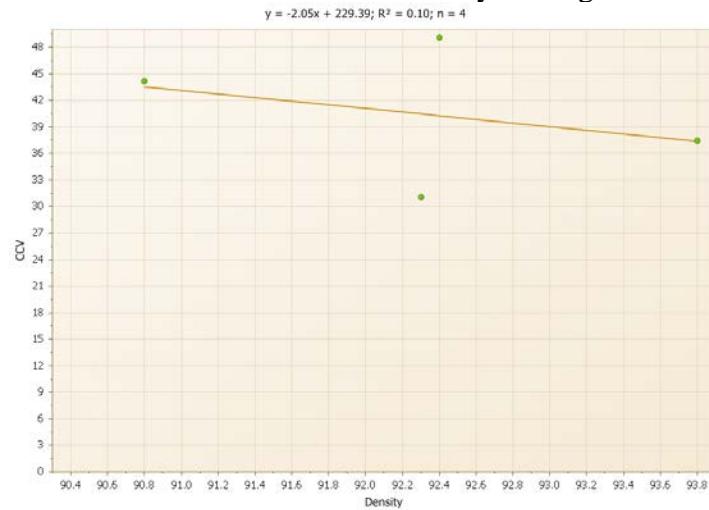
The Final Coverage CCV correlation with the core density is not good.

Figure 36: Veta Correlation Analysis Screen of IC Data Analysis (J5S3207 RT 54).

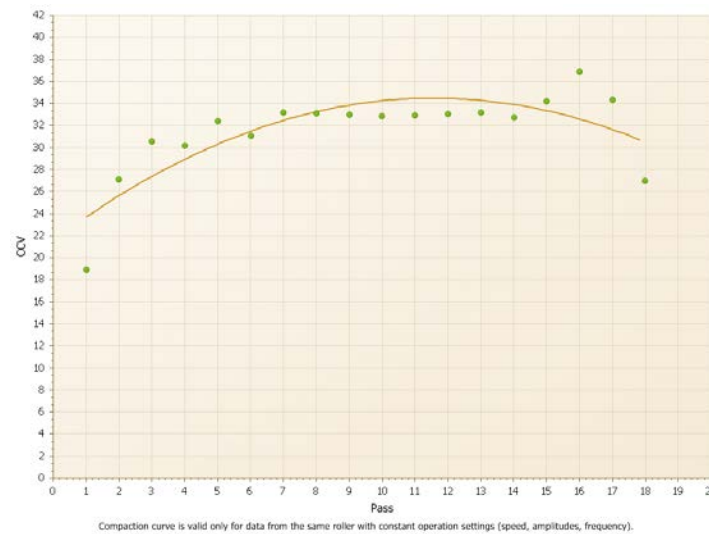
The All-passes CCV compaction curve (focusing on the first 5-7 passes), CCV does plateau around 5 passes.

Figure 37: Veta Compaction Curve Screen of IC Data Analysis (J5S3207 RT 54).

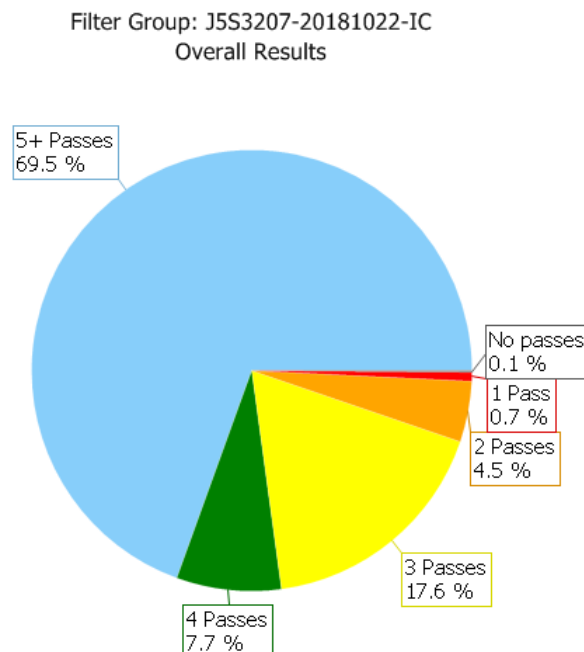
The overall pass count coverage is 59.5% that meet the target passes – just barely passing 70% requirement.

Figure 39: Veta Pass Count Coverage Screen of IC Data Analysis (J5S3207 RT 54).

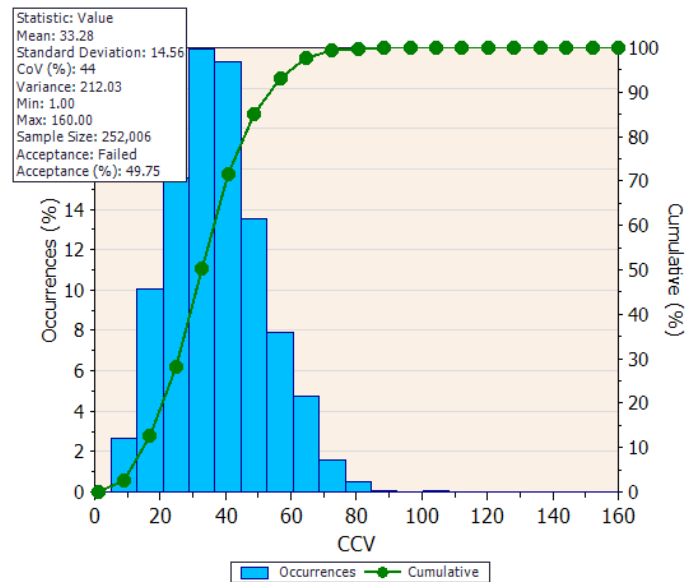
The target ICMV coverage is 49.75% which is less than the 70% requirement. However, due to the poor correlation between CCV and core density, this CCV data set is not recommended to be used for such analysis.

Figure 40: Veta CCV Statistics Screen of IC Data Analysis (J5S3207 RT 54).

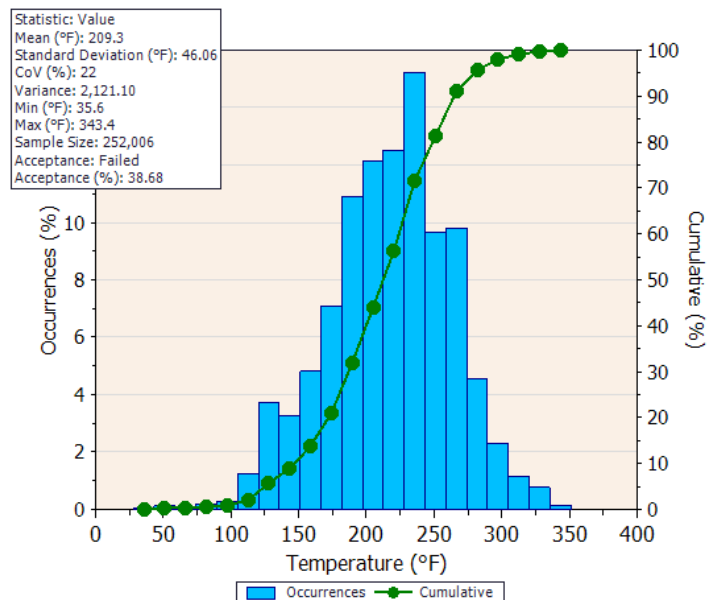
The target temperature coverage is 38.68%. It does not meet the MODOT's minimum temperature requirement of 225F.

Figure 41: Veta Temperature Statistics Screen of IC Data Analysis (J5S3207 RT 54).

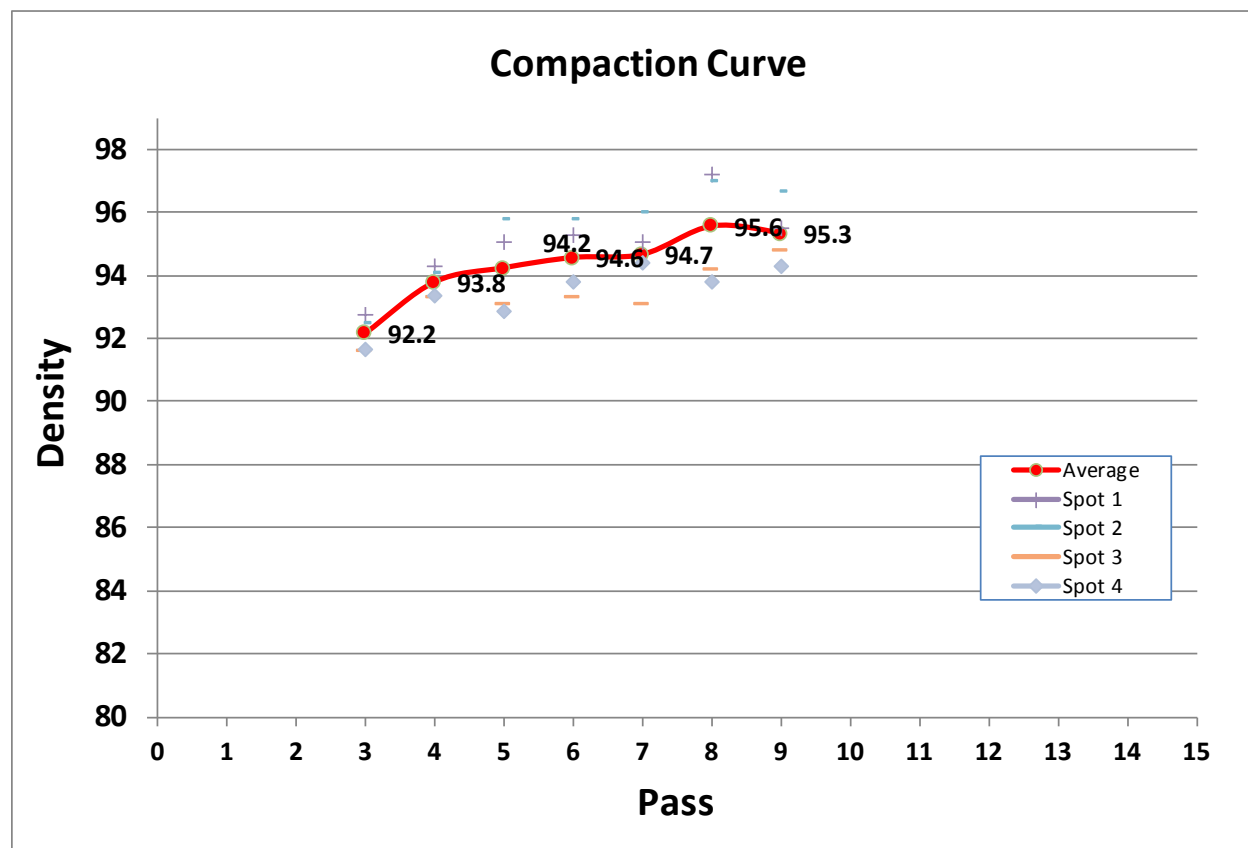
Optimum Rolling Pattern: The compaction curve is shown in **Error! Reference source not found.** The rolling pattern established was 5 vibratory passes with two breakdown IC rollers.

Figure 49: Density Compaction Curve from the Trial Section on 10/11/2018 (Project No. 3 - J113169, I-35)

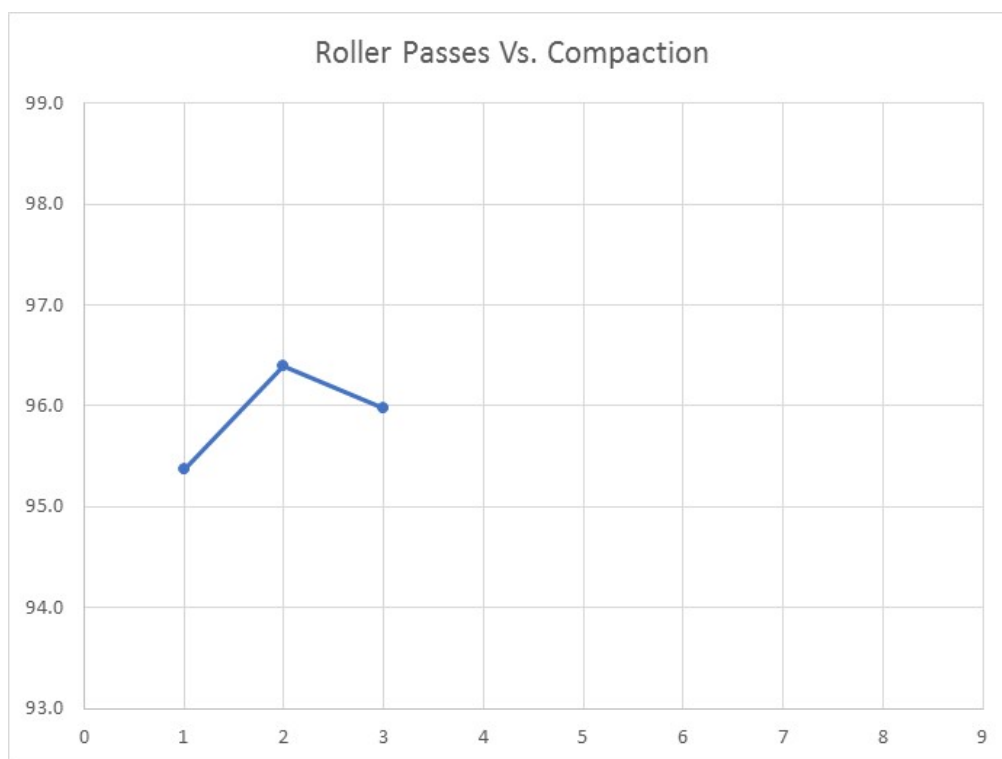
Optimum Rolling Pattern: Based on the compaction curve of trial section data, the rolling pattern is set to be 3 vibratory passes.

Figure 53: Density Compaction Curve from Trial Section 2018-09-04 (Project No. 4 - J9P3295, RT 160).

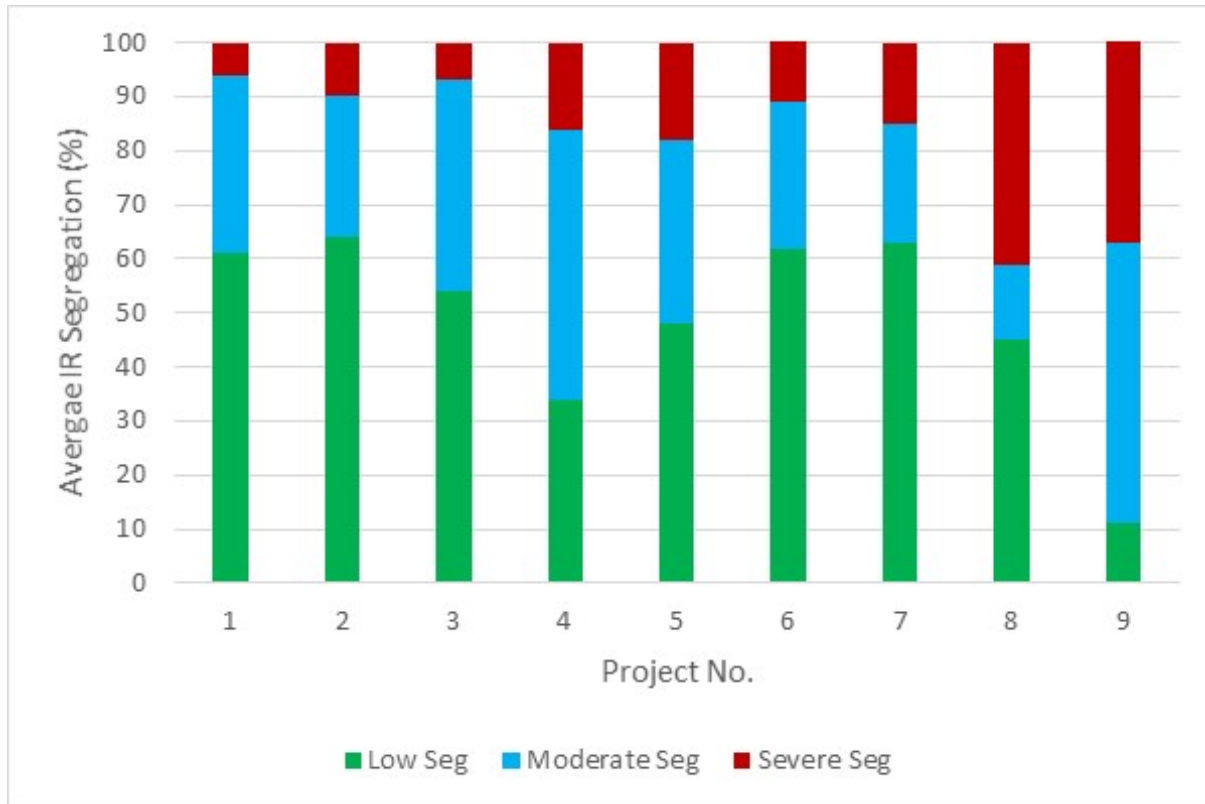
Figure 72: Comparison of IR Segregation for all projects.

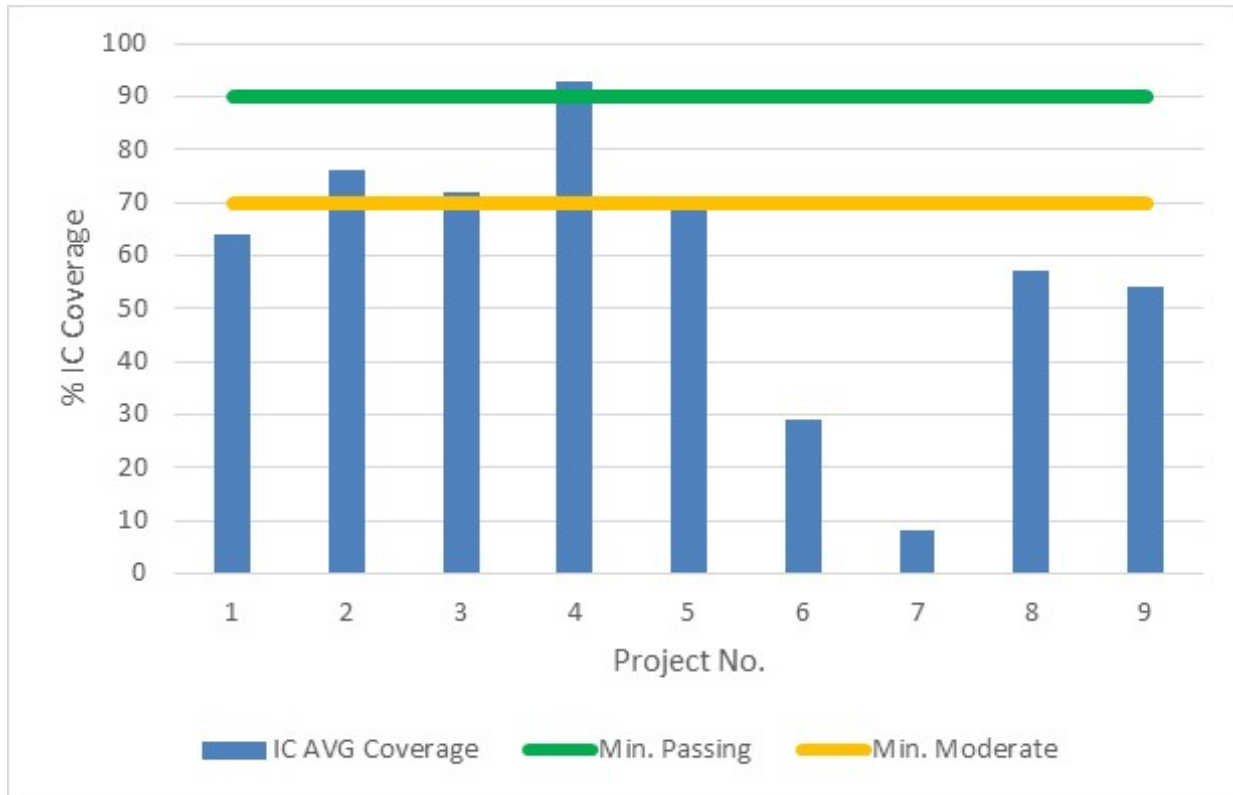
Figure 74: Comparison of IC Coverage for all projects.
