MoDOT Publication No. **TBA**

Consultant Support for IC-PMTPS Projects

2019 Final Report

The Transtec Group, Inc.
6111 Balcones Drive, Austin, Texas 78731

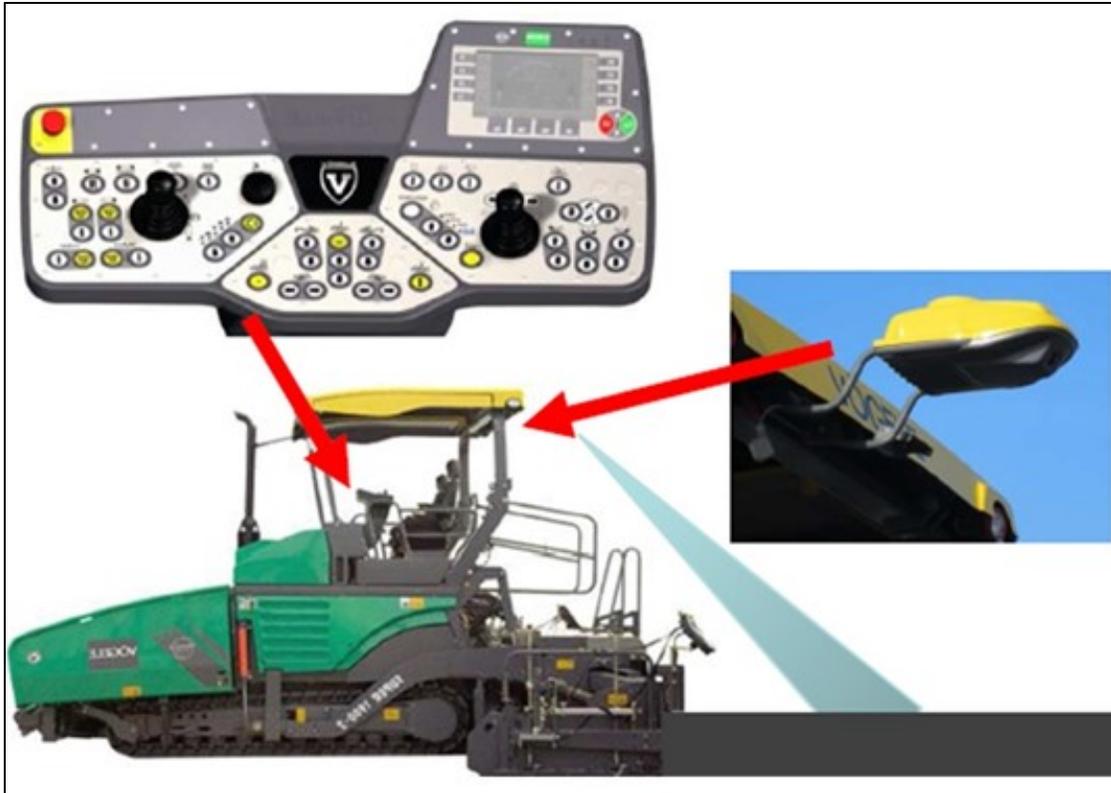
Figure 8: Vogele RoadScan Thermal Imaging System.

Currently, the Vogele RoadScan system can be mounted only on certain models of Vogele asphalt pavers. Images of the equipment are shown in Figure 8 and Figure 9.

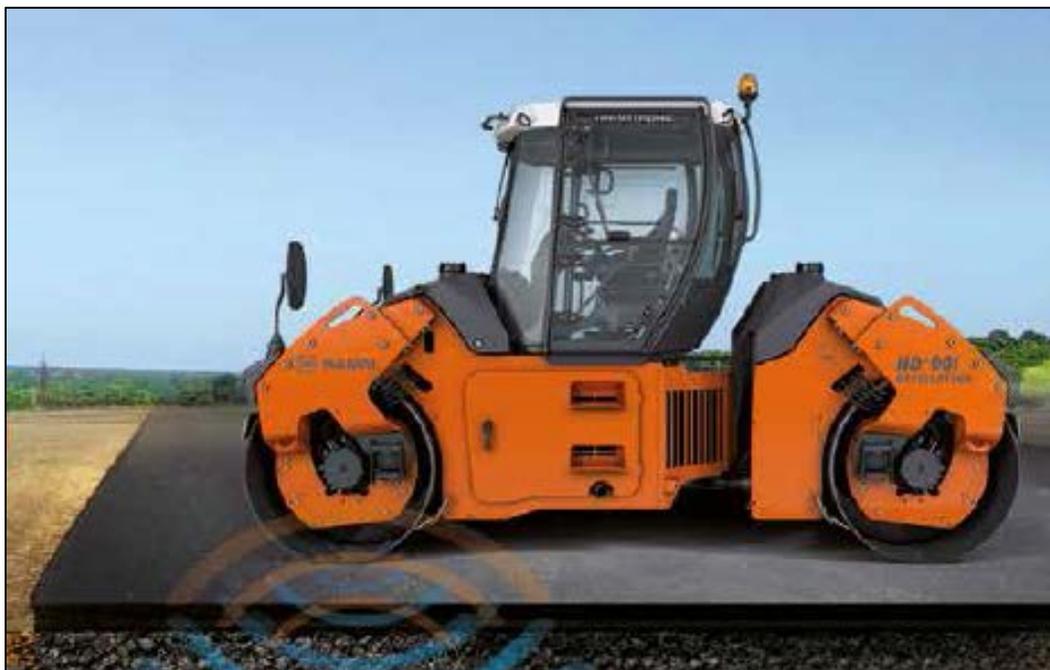
Figure 10: HAMM HCQ Intelligent Compaction System.

The HAMM Temperature Meter shows the current asphalt surface temperature. It enables the roller driver to decide where and how the asphalt needs to be compacted, thus making optimum use of the working time window and avoiding damage. The HAMM system is shown in Figure 10 and Figure 11.

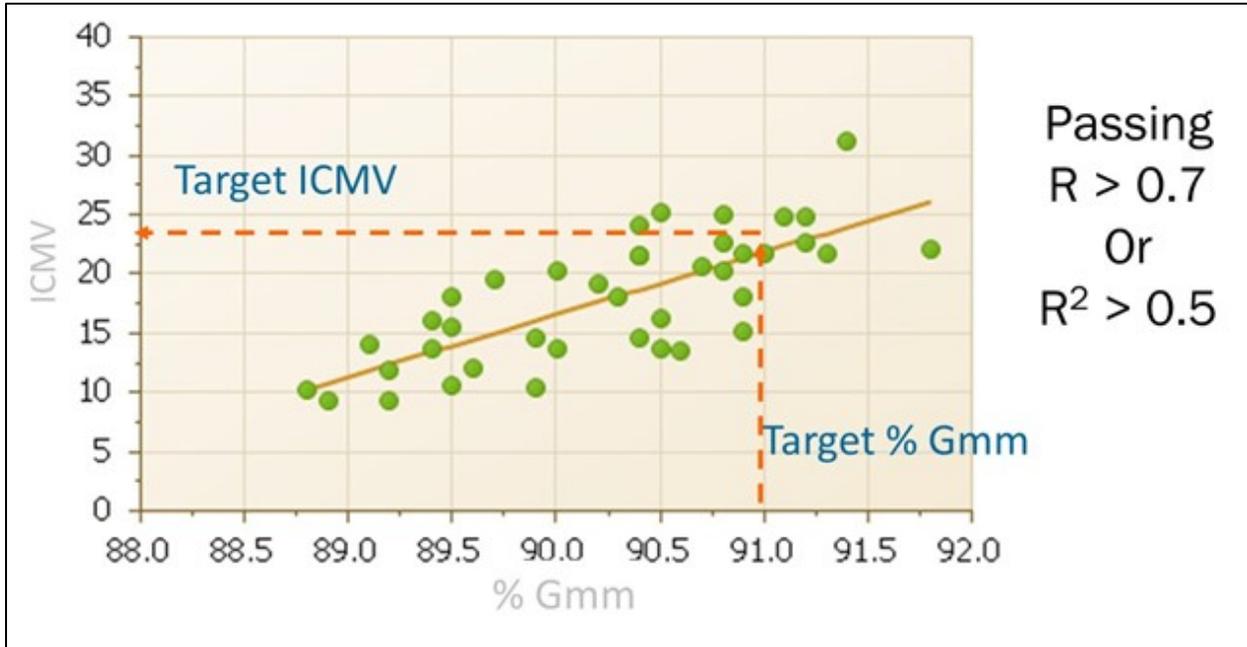
Figure 33: Target ICMV Determined by Correlation Between ICMV and Acceptance Spot Tests from Trial Section Data.

The target ICMV can be determined based on the correlation between the ICMV data and acceptance spot tests from the trial section (Figure 33). The requirements for the acceptable correlation between ICMV and acceptance spot tests is $R > 0.7$ or $R^2 > 0.5$, based on most of the international IC specifications.
