MoDOT Project No. TR202021

**CONSULTANT SUPPORT FOR INTELLIGENT COMPACTION AND PAVER-
MOUNTED THERMAL PROFILING PROJECTS IN 2020-2021**

2021 ANNUAL REPORT

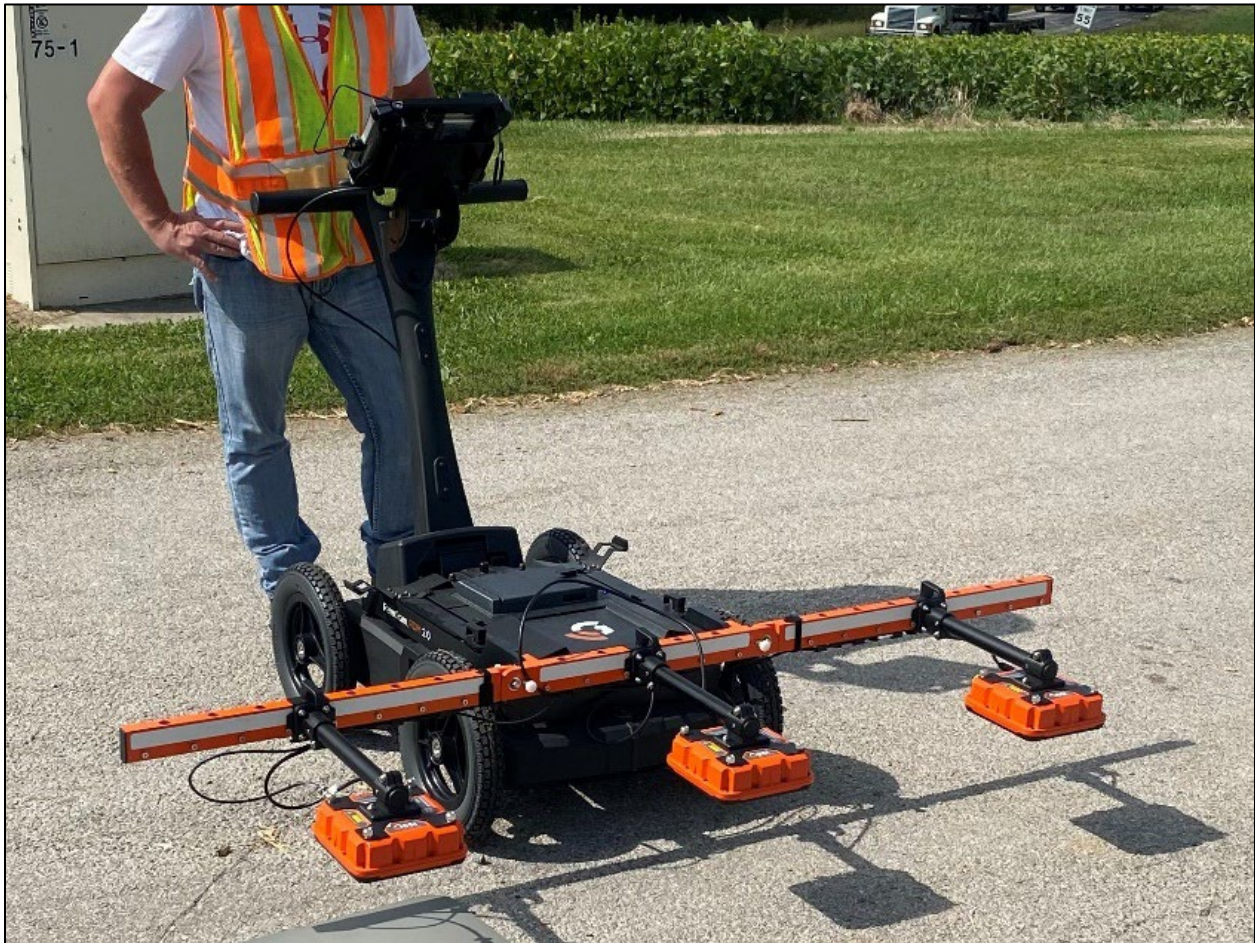
163 **Figure 1. Photo. RDM 2.0 DPS equipment**

157 The FHWA Equipment Loan Program at the Mobile Asphalt Technology Center (MATC)
158 (FHWA, 2020B) agreed to loan MoDOT a unit of the GSSI PaveScan Rolling Density Meter
159 (RDM) 2.0 (GSSI, 2020) for field testing and evaluation during the 2021 construction season.
160 The RDM 2.0 uses three GPR antennas mounted to a pushcart, as illustrated in Figure 1.

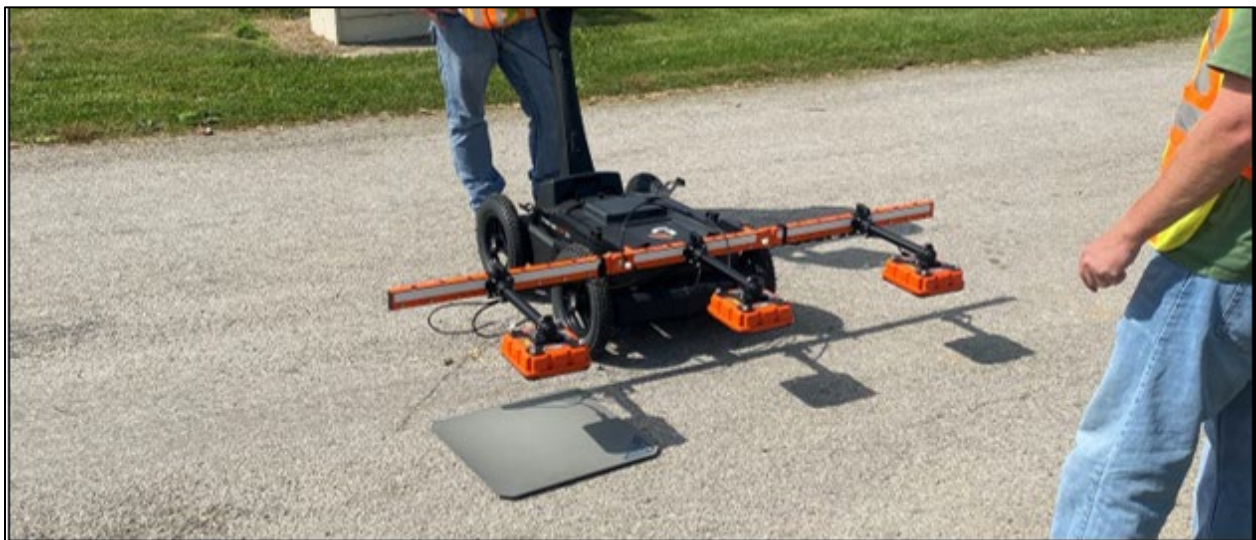
Figure 2. Photo. RDM 2.0 metal plate calibration.

A metal plate calibration must be performed with an airwave calibration (GSSI 2020). The metal plate calibration involves activating the sensors one at a time over a metal plate, as shown in Figure 2. The display will notify the user when the metal plate calibration is completed.

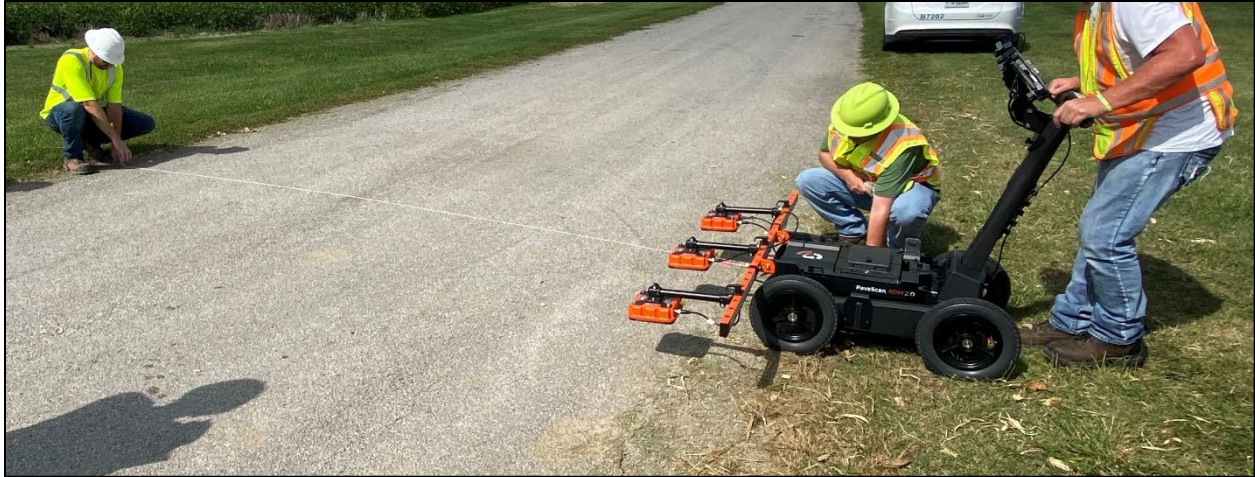
Figure 3. Photo. RDM 2.0 line calibration.

Line calibrations are performed using a string line to mark a 10-foot straight line transversely across the calibration site. Each sensor collects data along the 10-foot line, and a laser line is mounted on each sensor to help keep the sensor on the line. The median dielectric value is compared for each sensor, and the dielectric values should be within 0.08 of each other (MATC 2021). An example of line calibration performance is shown in Figure 3.

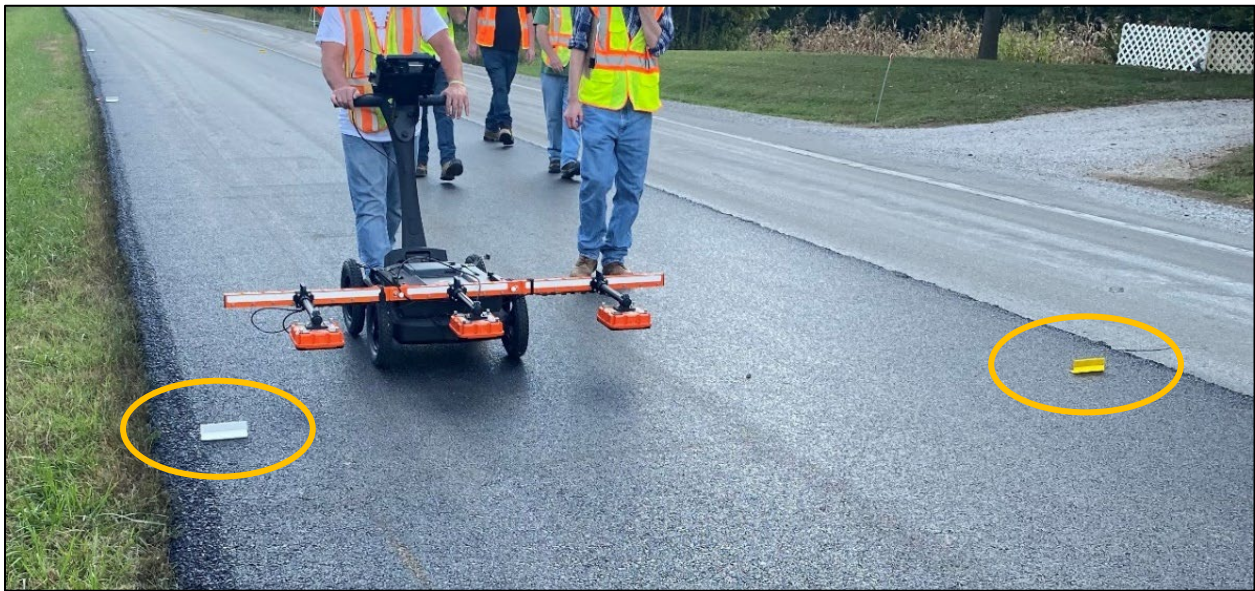
The DPS equipment was set up with a 2-foot sensor offset for a total collection width of 4 feet. The 2-foot offset was the preferred setup because the contractor's temporary lane markings were placed inside the lane, as shown in Figure 24. The temporary lane markings caused erroneous readings, and therefore, only 8 feet of the total width of the mat was collected. Veta has filtering capabilities to remove such obstructions after data collection. Therefore, it is recommended that full-width data be collected in the future. There is some error in GPS and human-induced wander, and therefore, each 4-foot width varies by location. The data wander is further illustrated under section 4.2.3.2.

Figure 6. Photo. Temporary lane markings on either side of the pavement interfere with RDM readings (false low density, out of range density).

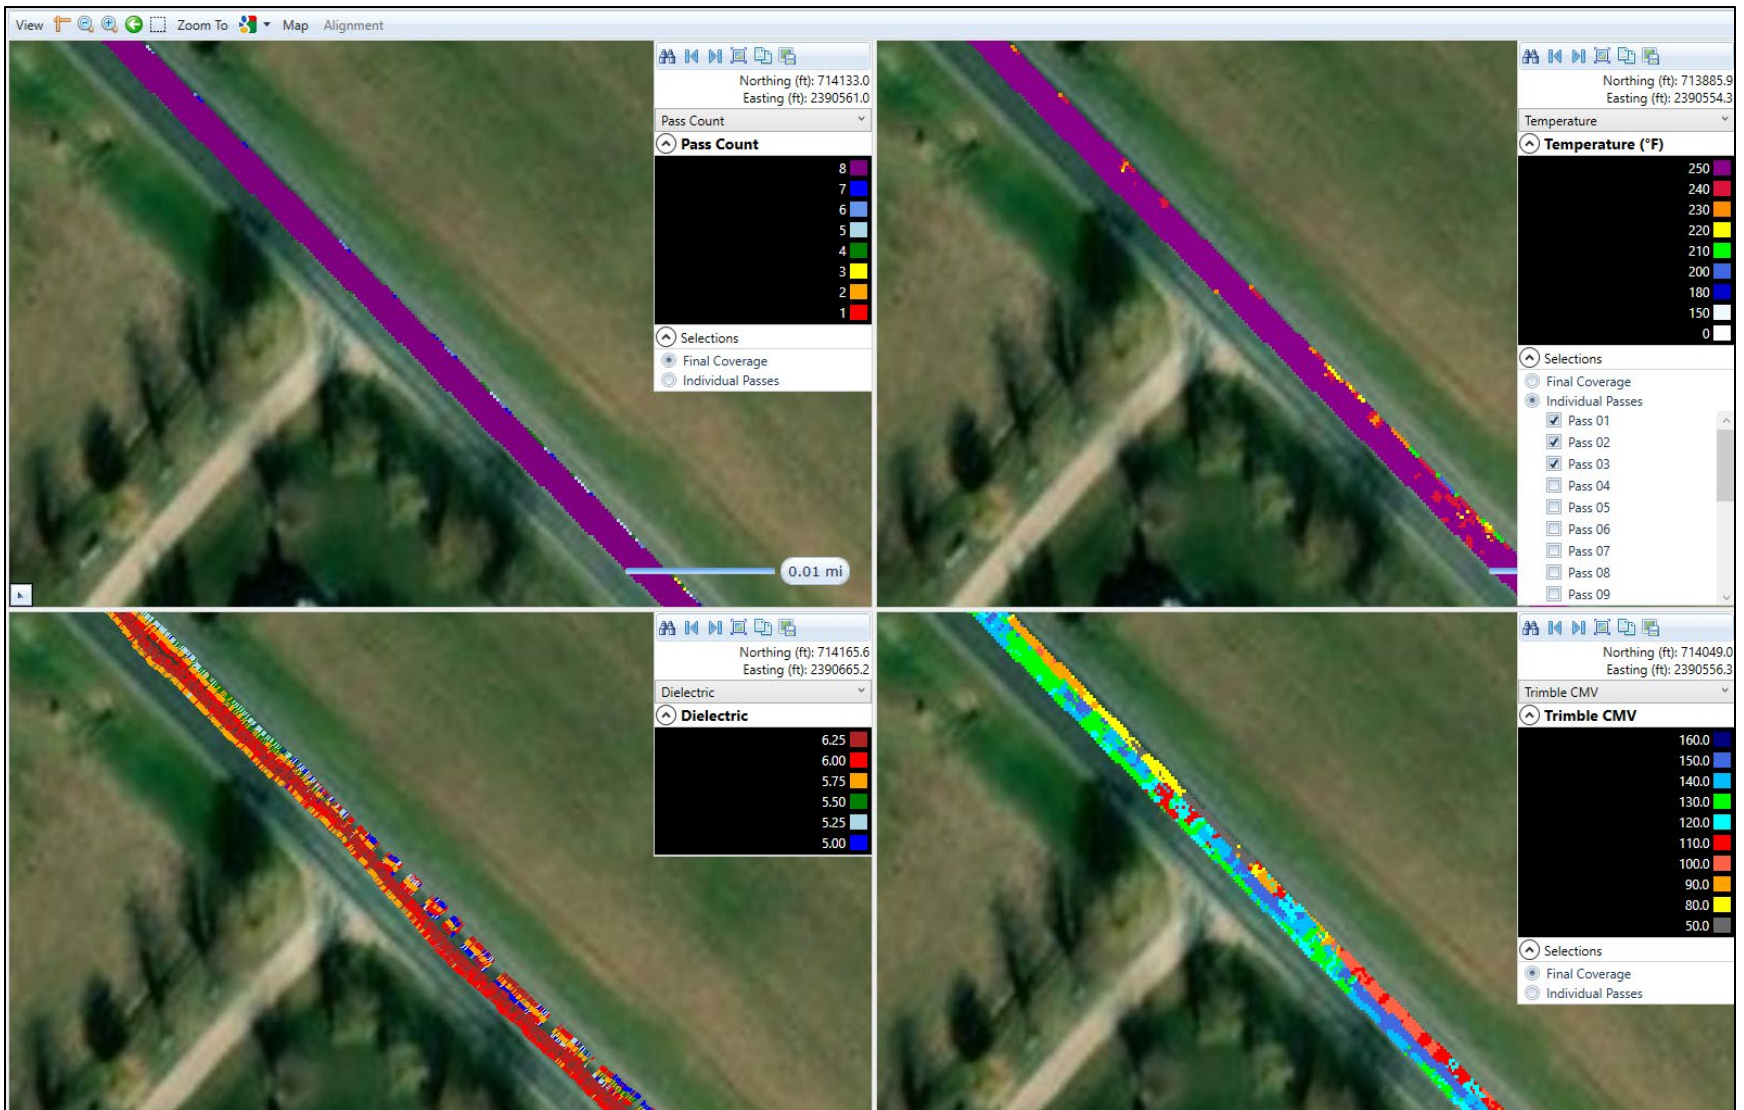
337 **Figure 14. Screenshot. IC pass count (top left), IC temperature (top right), DPS (lower left), and IC ICMV (lower right) data.**

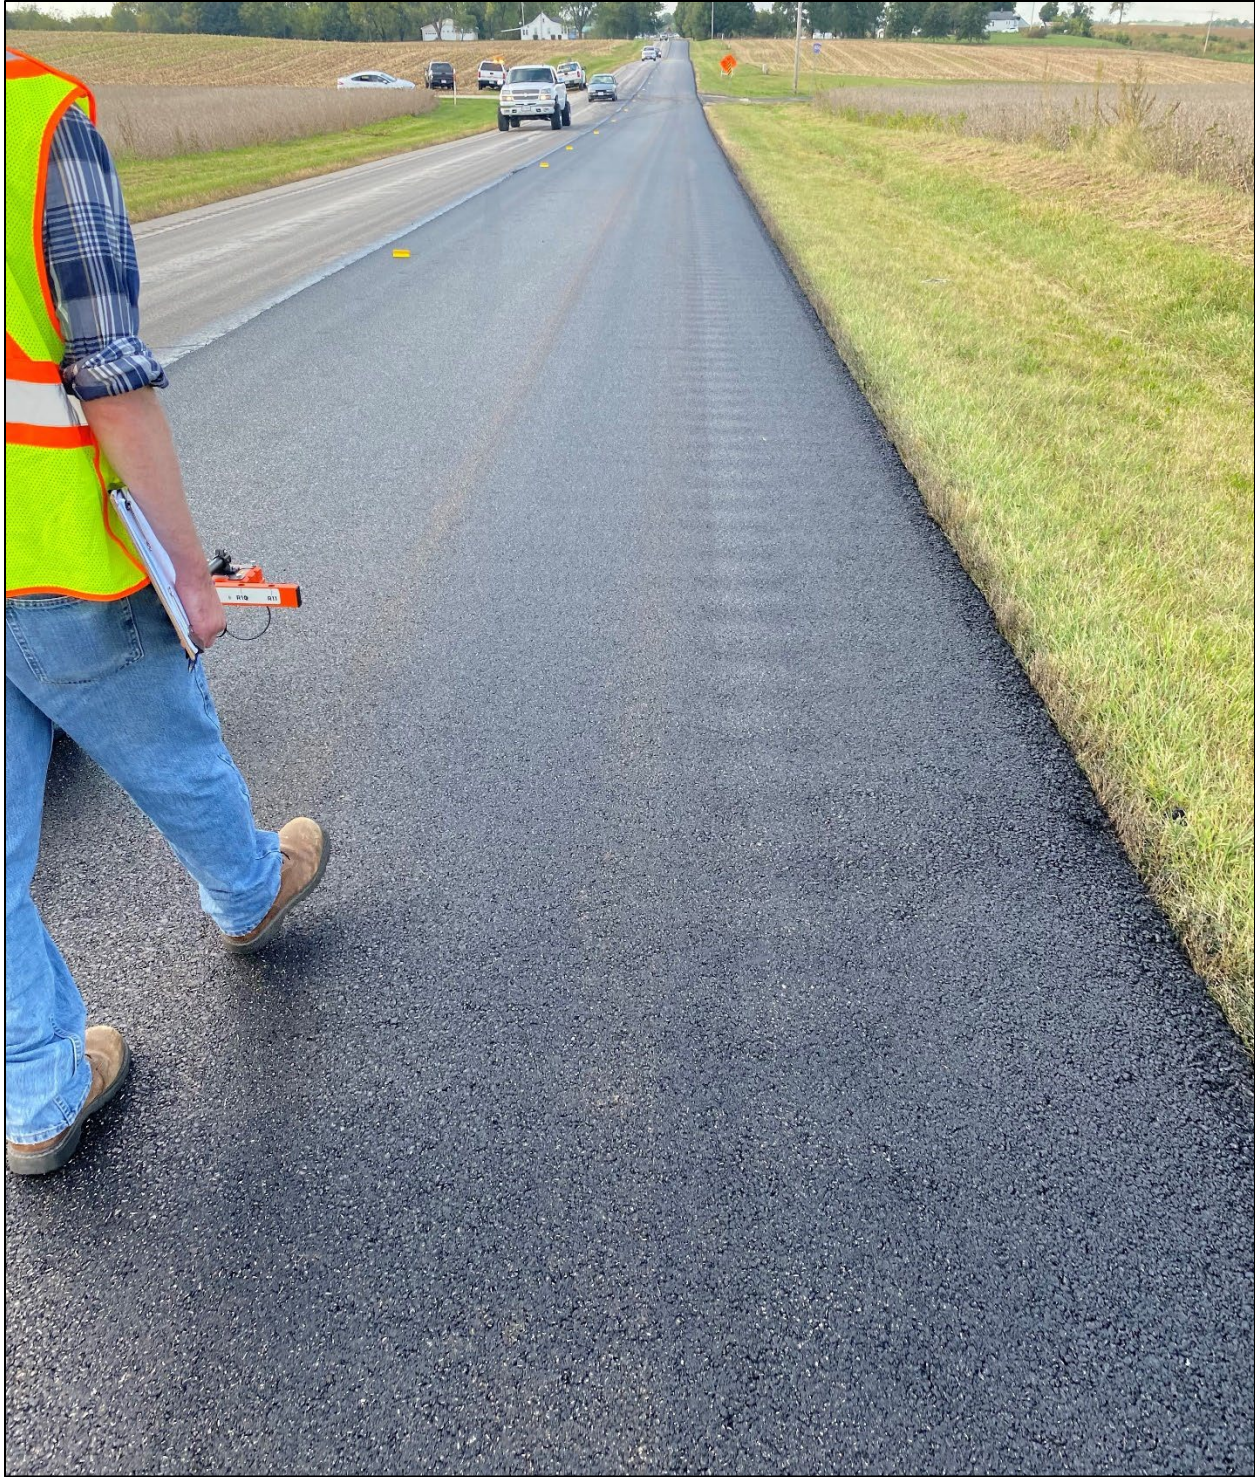
Also, the overlay was placed over the existing rumble strip. The rumble strips are reflected through the overlay, as shown in Figure 15. Paving over the rumble strips could contribute to the lower stiffness values as compaction efforts will vary across the high and low elevations of the existing surface.

Figure 15. Photo. Rumble strips are shown reflecting through the overlay.

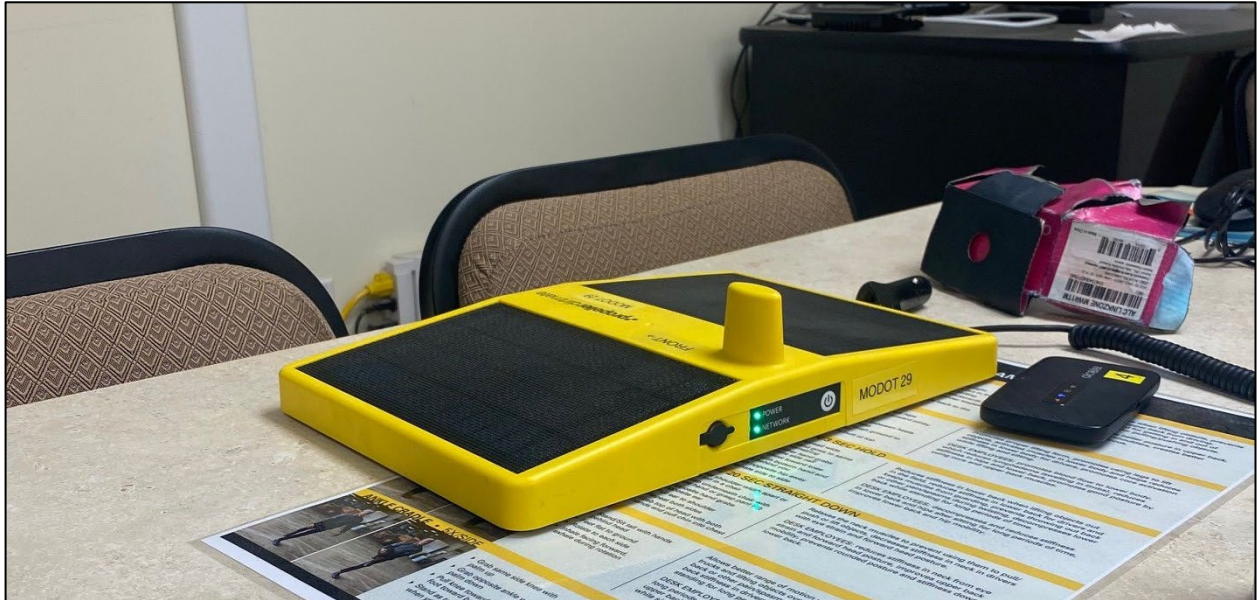
Figure 18. Photo. Propeller DirtMate.

following morning to troubleshoot. It was recommended that MoDOT mark the mounting location of the DirtMate on the roller so that it could be placed in the same location after troubleshooting. The DirtMate is illustrated in Figure 18, and the hotspot is illustrated in Figure 19.

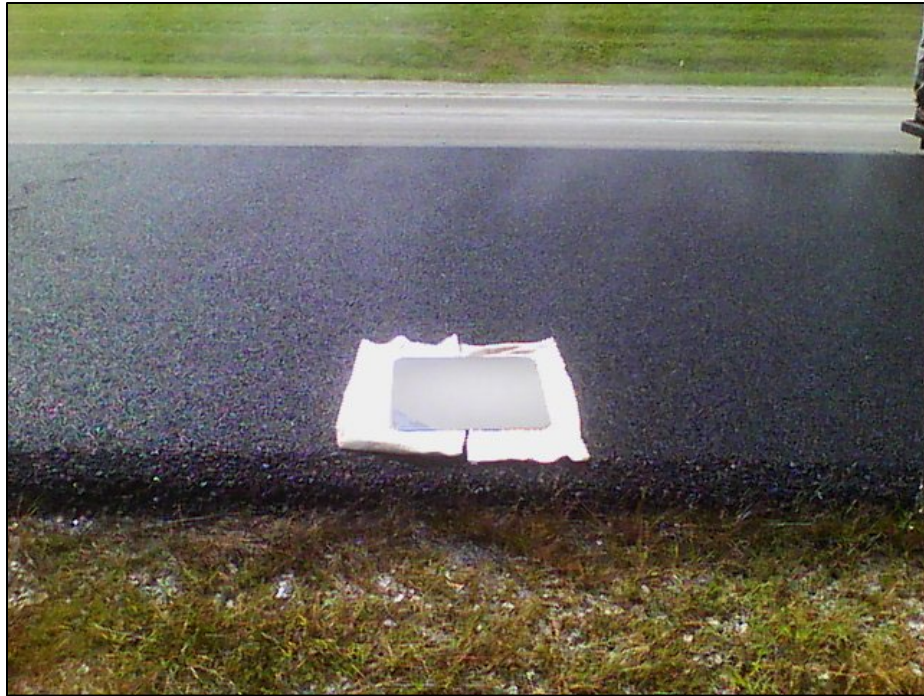
Figure 24. Photo. Improvised reference object met the dimensions required and stayed below 150°F during testing.
